Central Florida Commuter Rail Transit

Cultural Resource Assessment Survey Technical Memorandum

OCTOBER 2009

**CENTRAL FLORIDA COMMUTER RAIL TRANSIT
(SUNRAIL)
SEVEN PROPOSED STATION SITES IN
OSCEOLA, ORANGE, SEMINOLE, AND VOLUSIA COUNTIES,
FLORIDA**

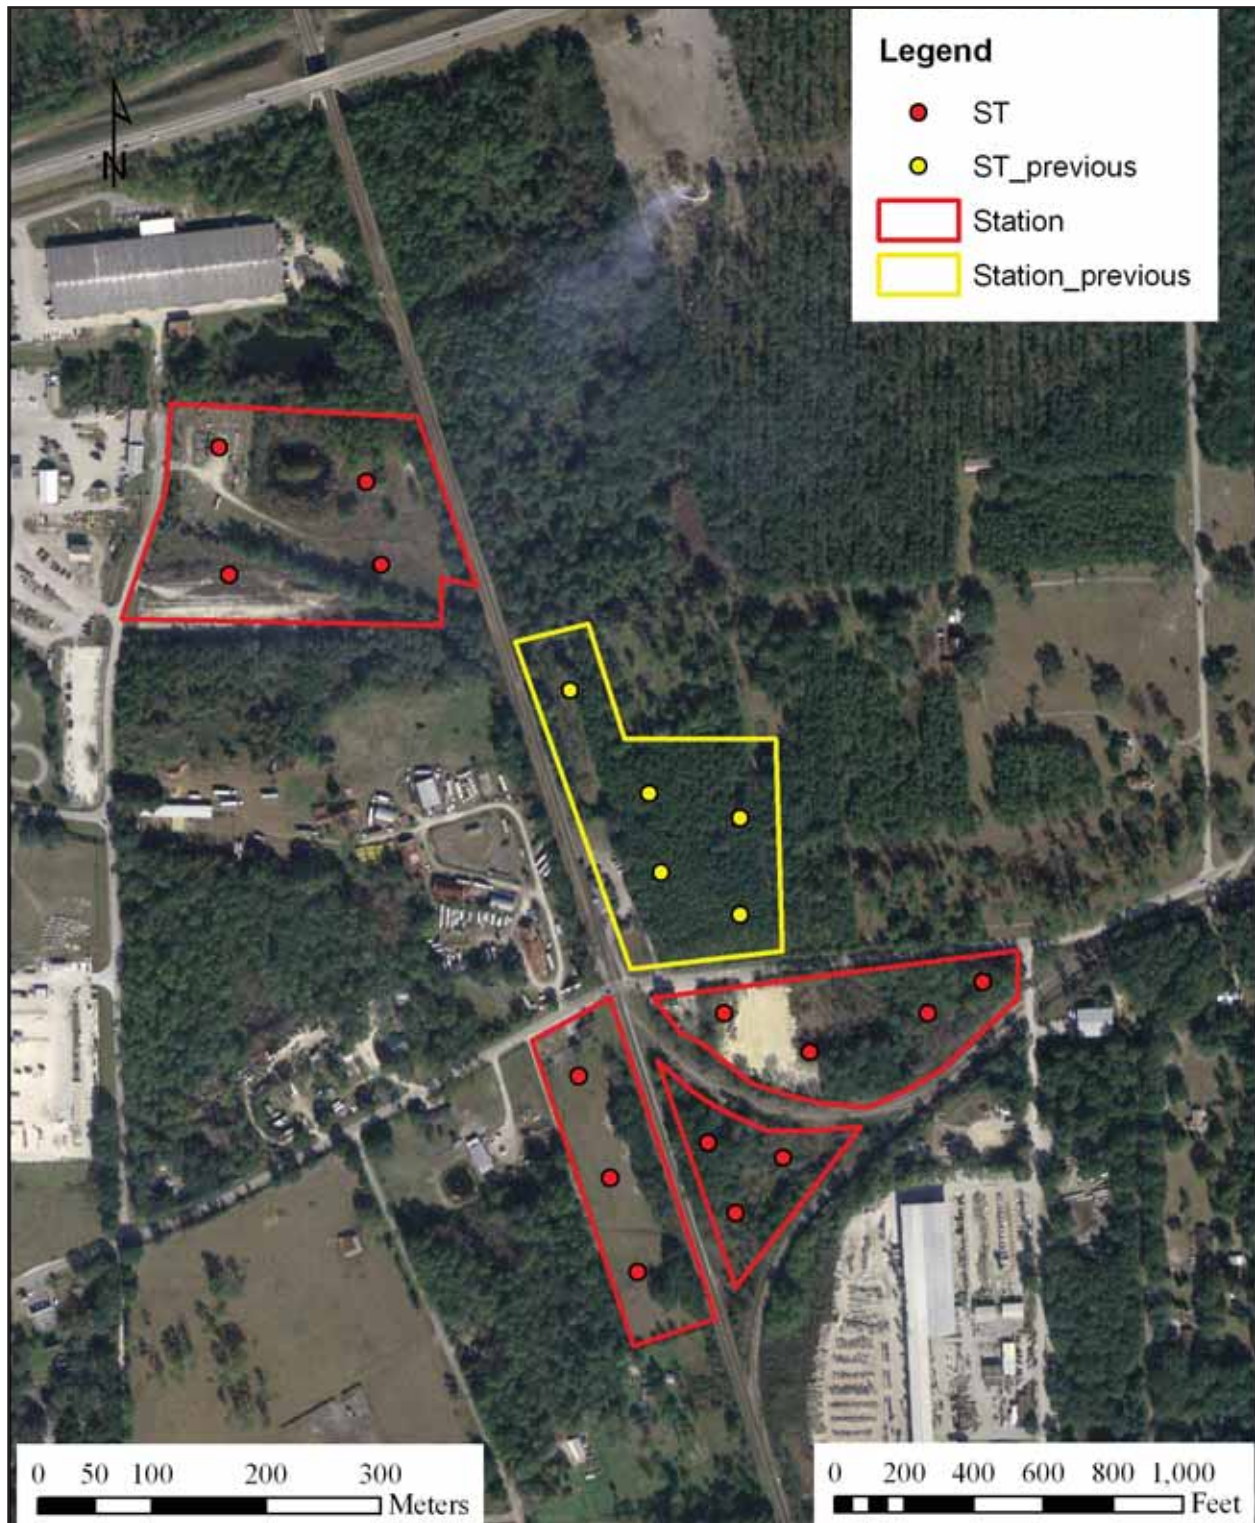
Figure 1. Approximate location of the shovel tests within the proposed DeLand Amtrak Station parcels (United States Geological Survey [USGS] 2004b).

Archaeological field survey entailed an initial ground surface inspection followed by judgmental subsurface testing throughout the four parcels (**Figure 1**). Four tests were placed in the parcel west of the railroad and east of Fair Street. The stratigraphy consisted of 0-30 cm (0-12 in) of dark gray sand underlain by light gray sand. Three tests placed in the parcel west of the railroad and south of Old New York Avenue, as well as three within the parcel east of the railroad revealed a similar stratigraphic profile. Four shovel tests were excavated within the parcel located south of the DeLand ACL Railroad Station. The stratigraphy consisted of 0-30 cm (0-12 in) dark gray sand, 30-80 cm (12-32 in) gray sand, and 80-100 cm (32-39 in) black hardpan. Of the total 14 shovel tests excavated, all yielded negative results.

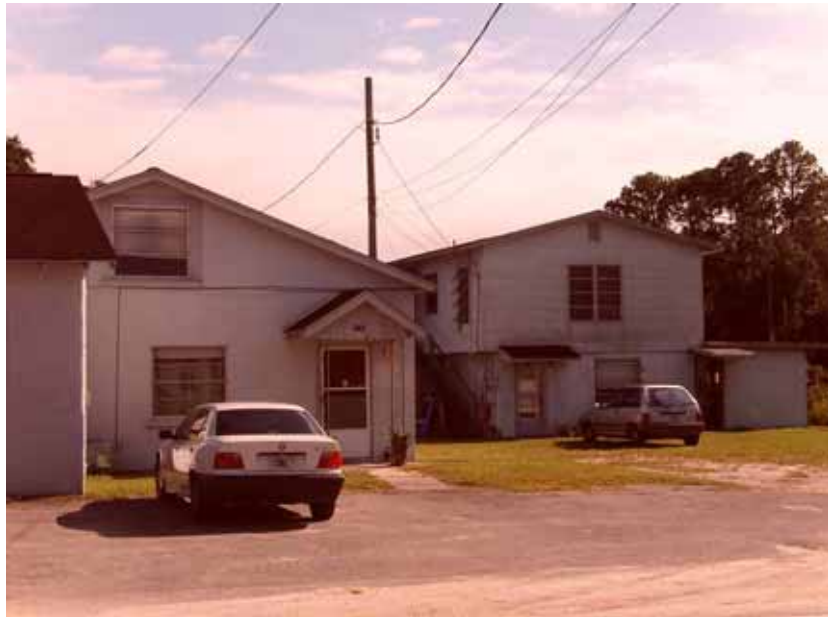
Photo 4. 2504 (8VO7606) and 2510 (8VO7605) Old New York Avenue, looking north.

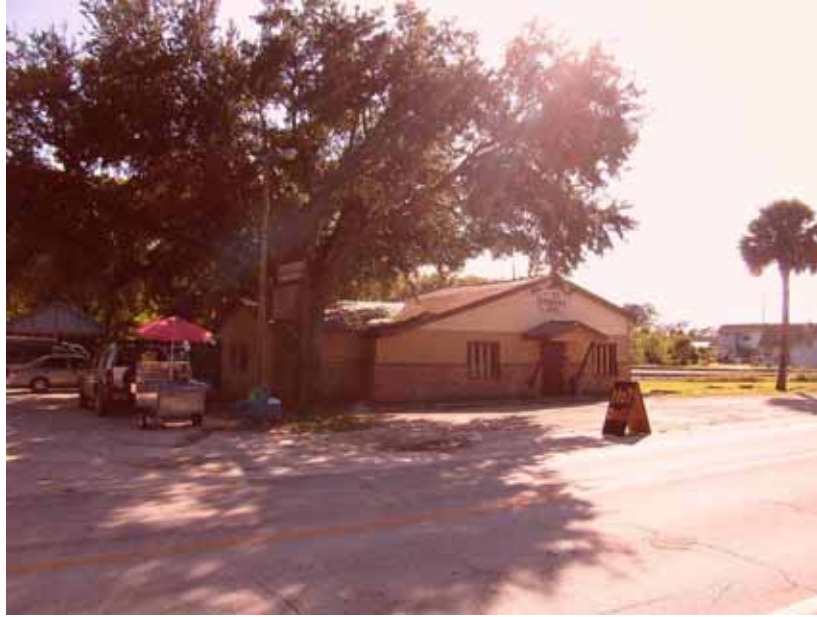
Photo 5. 8VO7607 at 2486 Old New York Avenue.

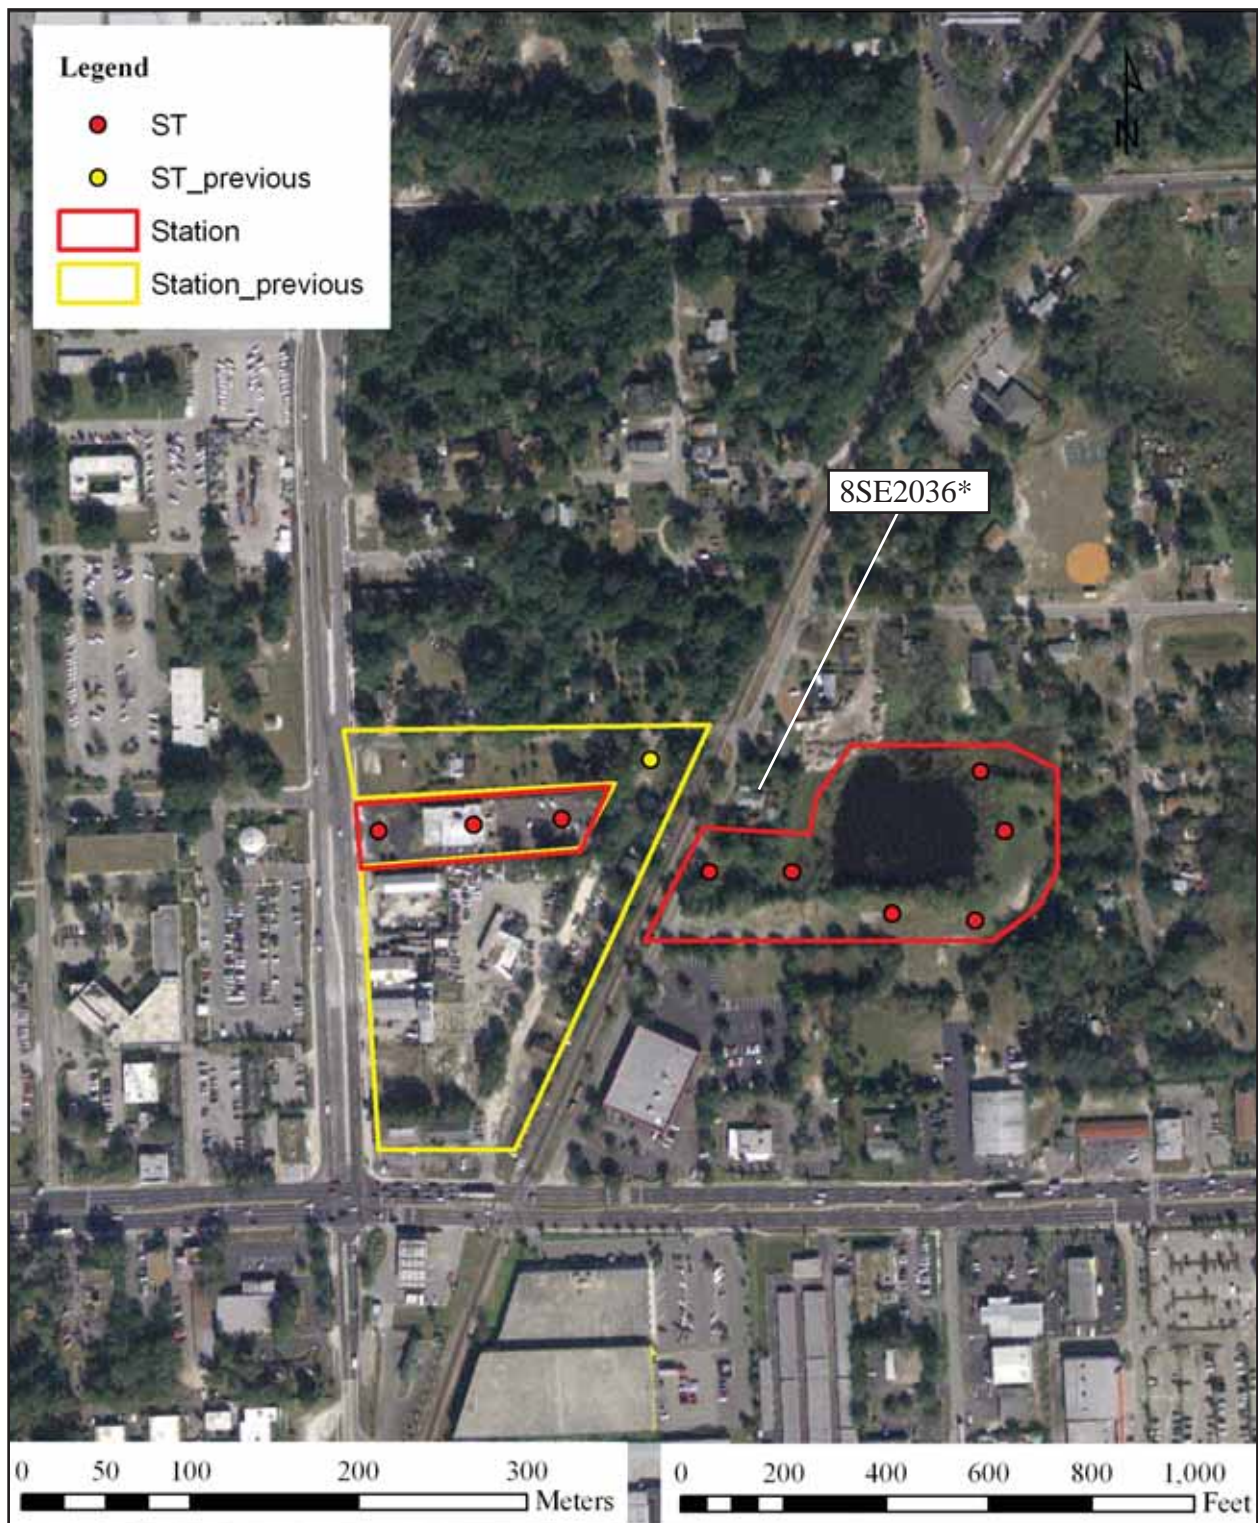
Figure 2. Approximate location of the shovel tests within the proposed Altamonte Springs Station parcels. Asterisk denotes previously recorded historic structure 8SE2036 (USGS 2004a).

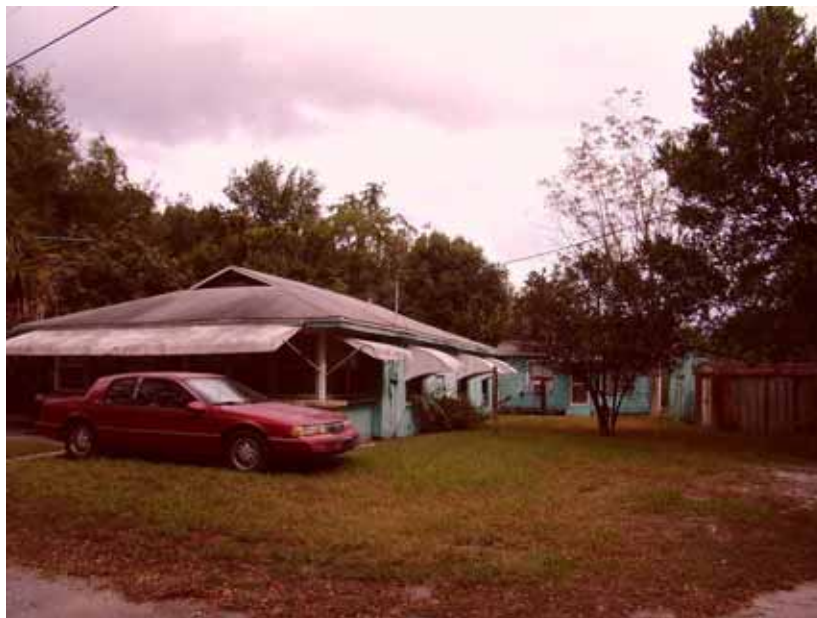
One previously recorded historic resource, 8SE2036, is located within the APE of the proposed Altamonte Springs Station Site. This ca.1946 Masonry Vernacular style residence (**Figure 2; Photo 8**) is located at 109 Station Street, adjacent to the eastern parcel. It was evaluated as ineligible for listing in the NRHP (ACI 2005). A copy of the FMSF form for 8SE2036 is contained in the Appendix. No new historic resources were identified within the project APE for this station site.

Photo 8. 8SE2036 at 109 Station Street, looking east.

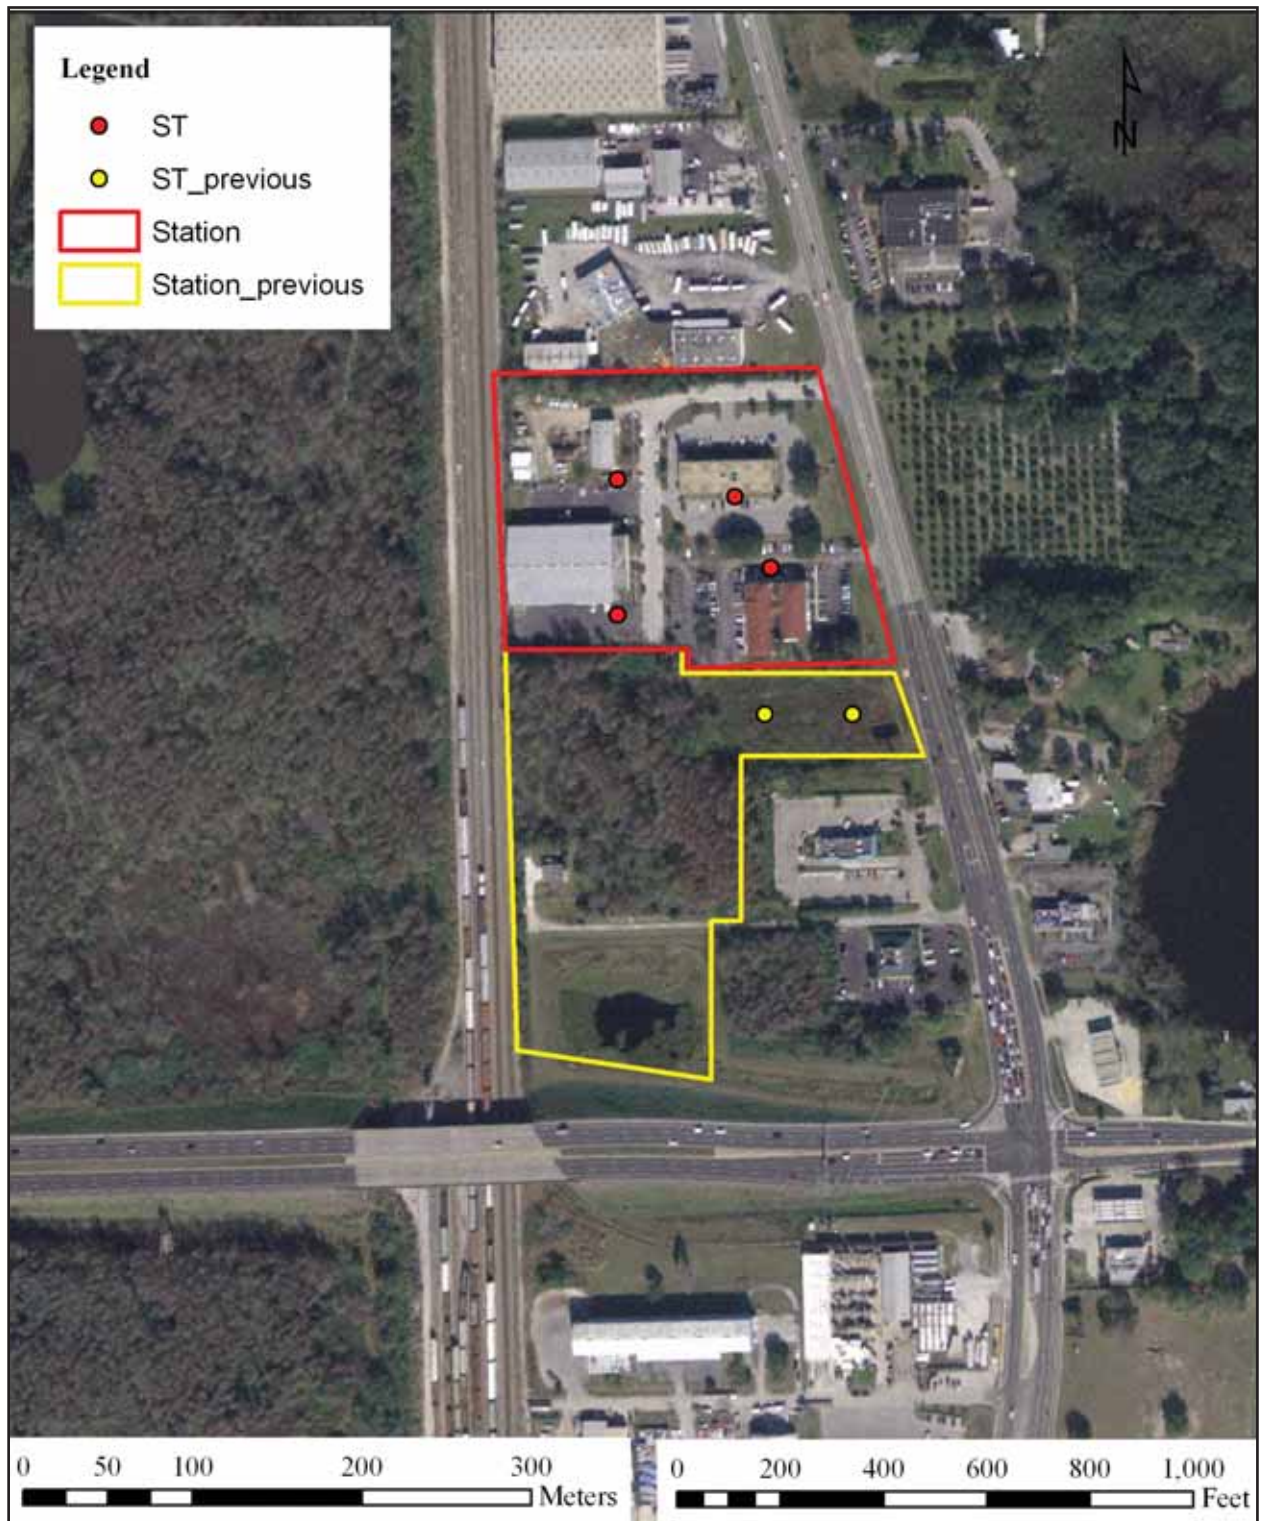
Figure 3. Approximate location of the shovel tests within the proposed Sand Lake Road Station parcels (USGS 2004d).

Archaeological field survey entailed an initial ground surface inspection followed by judgmental subsurface testing throughout the parcel (**Figure 3**). Four shovel tests were excavated, revealing a stratigraphy of 0-75 cm (0-30 in) gray sand, underlain by light brown sand. No cultural materials were recovered from any of the tests or during the surface reconnaissance. No historic resources were identified.

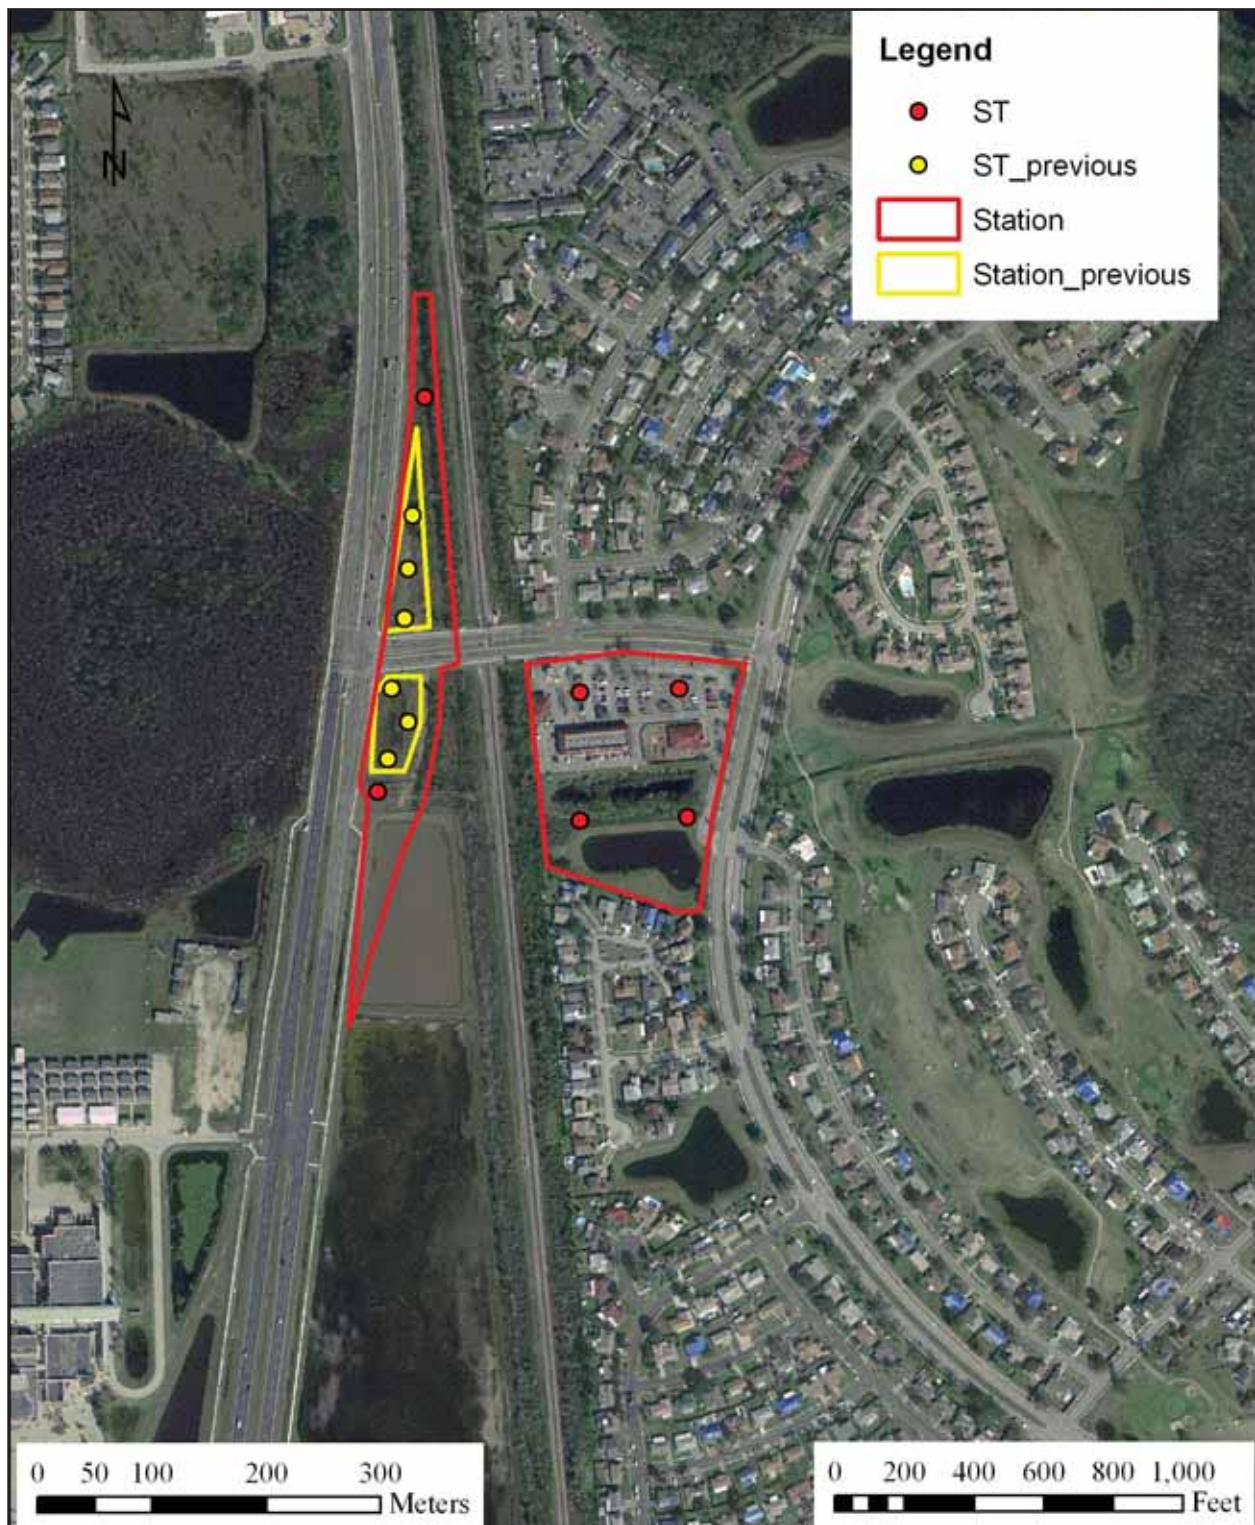
Figure 4. Approximate location of the shovel tests within the proposed Meadow Woods Station parcels (USGS 2004d).

Archaeological field survey entailed an initial ground surface inspection followed by judgmental subsurface testing (**Figure 4**). Two shovel tests were excavated within the western parcel revealing a stratigraphy of 0-100 cm (0-39 in) dark gray muck at the south end and grayish brown sand at the north end. The four shovel tests excavated within the eastern parcel revealed a stratigraphy of 0-60 cm (0-24 in) of dark gray sand underlain by light gray sand. No cultural materials were recovered from any of the tests or during the surface reconnaissance. Historical/architectural field survey similarly produced negative results.

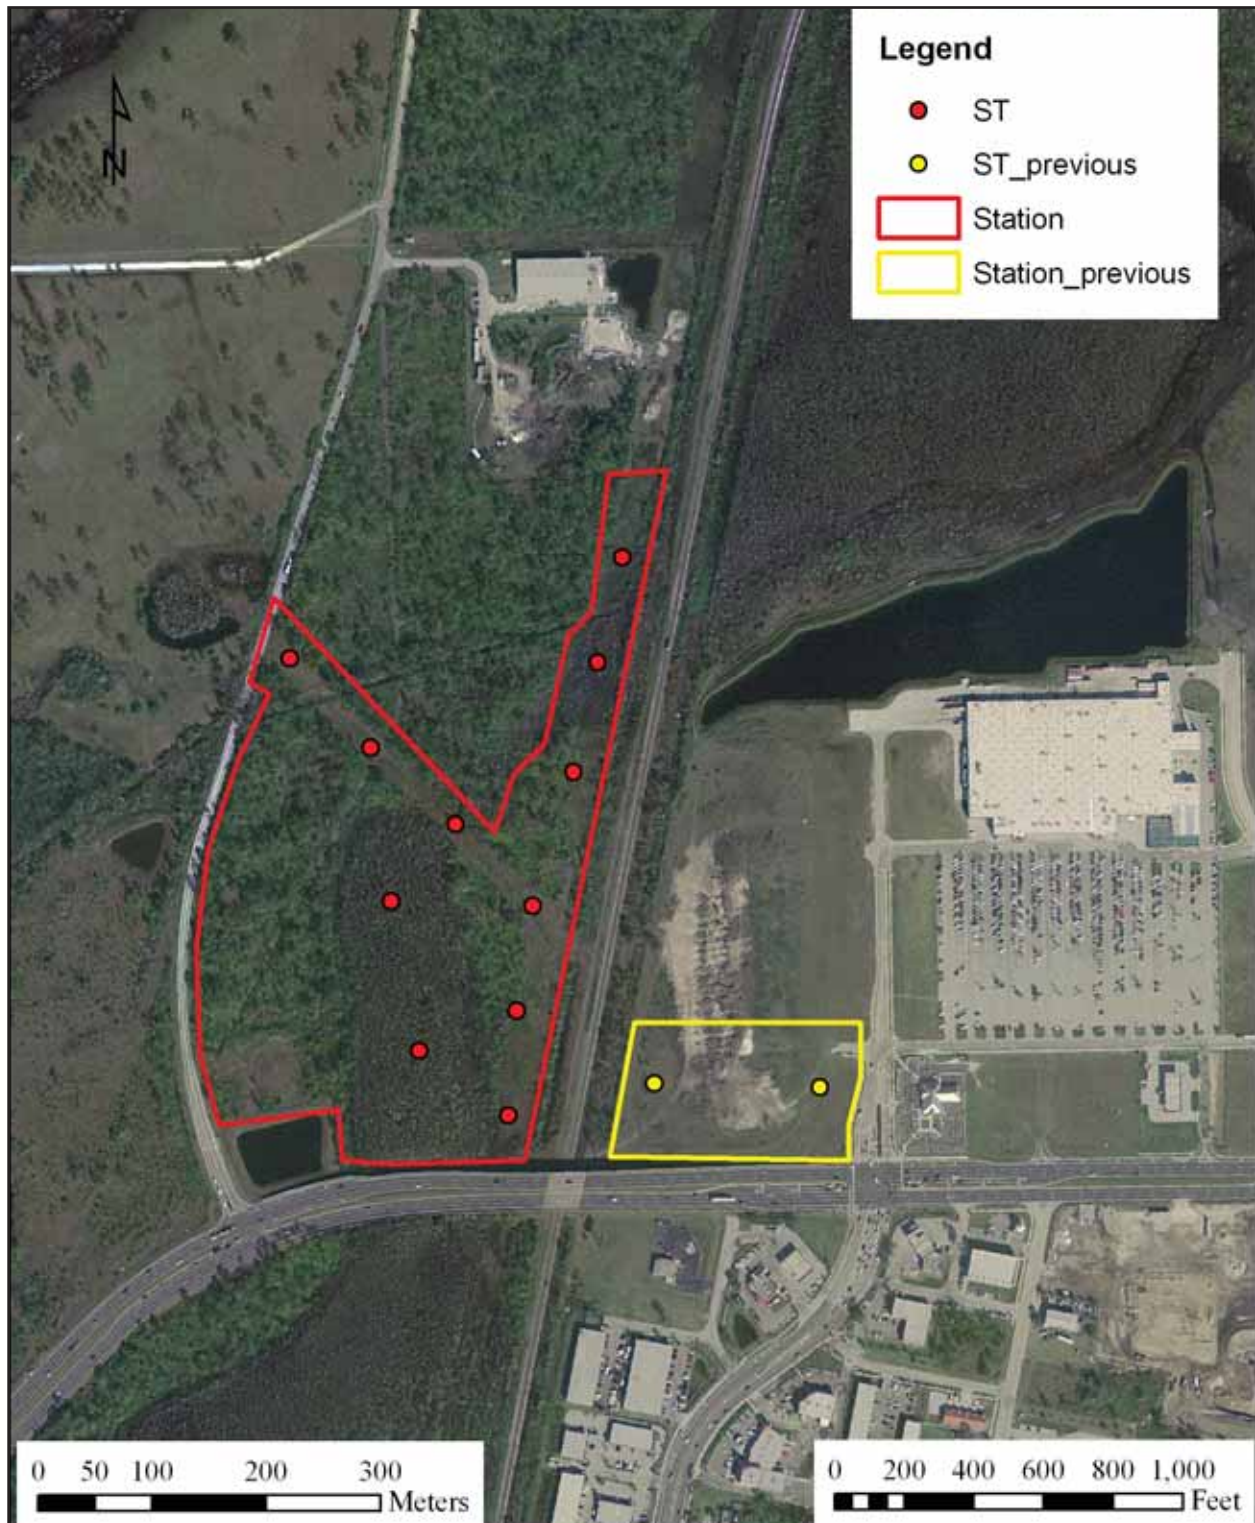
Figure 5. Approximate location of the shovel tests within the proposed Osceola Parkway Station parcels (USGS 2004c).

Archaeological field survey entailed an initial ground surface inspection followed by judgmental subsurface testing throughout the parcel (**Figure 5**). Eleven shovel tests were excavated throughout the tract revealing a stratigraphy of 0-100 cm (0-39 in) dark grayish brown sand in the flatwoods and black muck and water in the cypress dome. No cultural materials were recovered from the tests or during the surface reconnaissance. No historic resources were identified as the result of historical/architectural field survey.

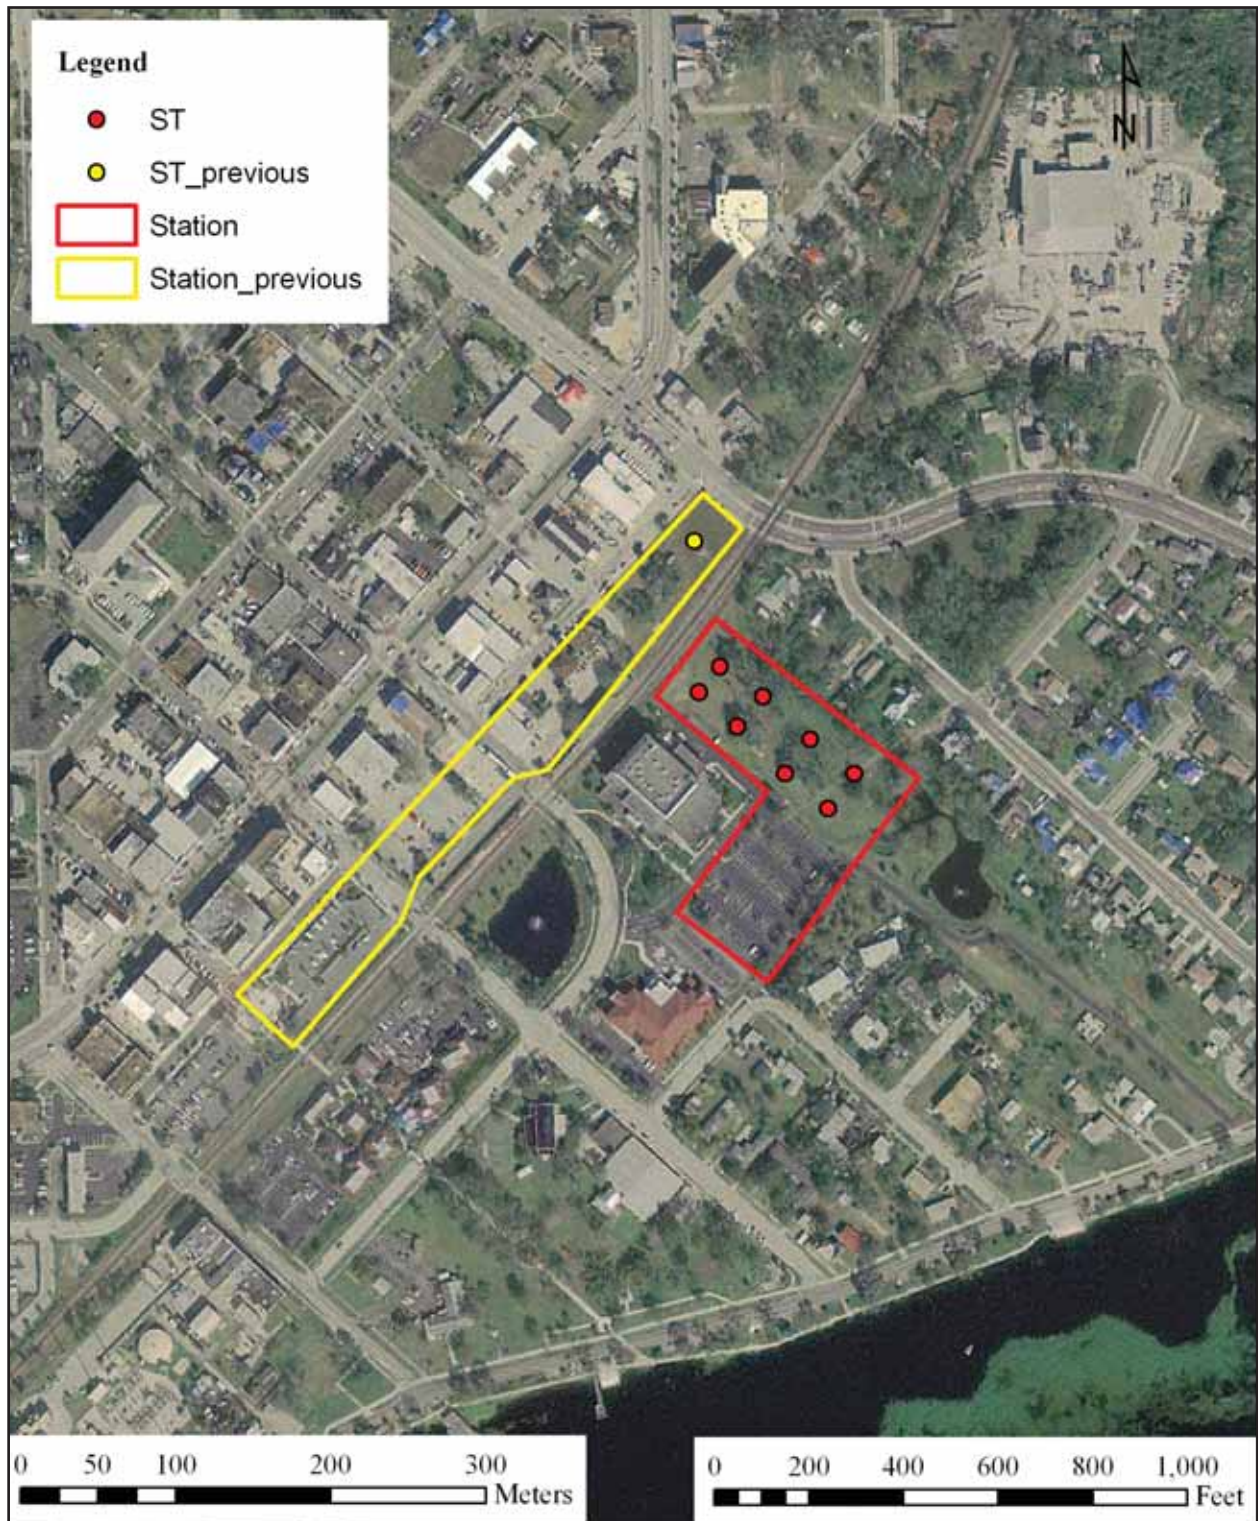
Figure 6. Approximate location of the shovel tests within the proposed Kissimmee Amtrak Station parcels (USGS 2004c).

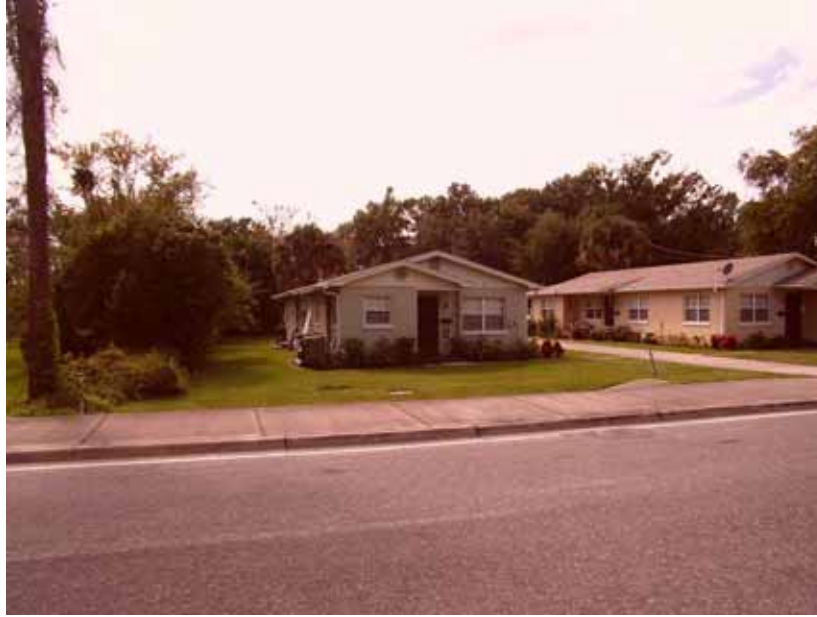
Photo 14. Northeast elevation of 214 E. Drury Avenue, 8SO2570.

8OS2570: The Masonry Vernacular style residence, at 214 E. Drury Avenue, was constructed ca. 1940 (**Photo 14**). The concrete block walls, supported by the slab foundation, are topped with a gable roof with asphalt shingles (ca. 2003). The replacement windows are six-over-six single hung sash (ca. 2003) and have projecting window sills. An original inset porch is on the northeast elevation and contains the main entrance. Other original architectural features include gable vents, scrolled porch posts, and vertical board in the gables. This is an example of a commonly occurring Masonry Vernacular style residence found throughout Osceola County and research did not reveal significant historic association with an individual or event. Therefore, 8OS2570 does not appear eligible for listing in the NRHP. However, this building is near identical to the adjacent property at 212 E. Drury Avenue (8OS1954), which was considered a potentially contributing resource to the potential Cape Breeze Historic District.

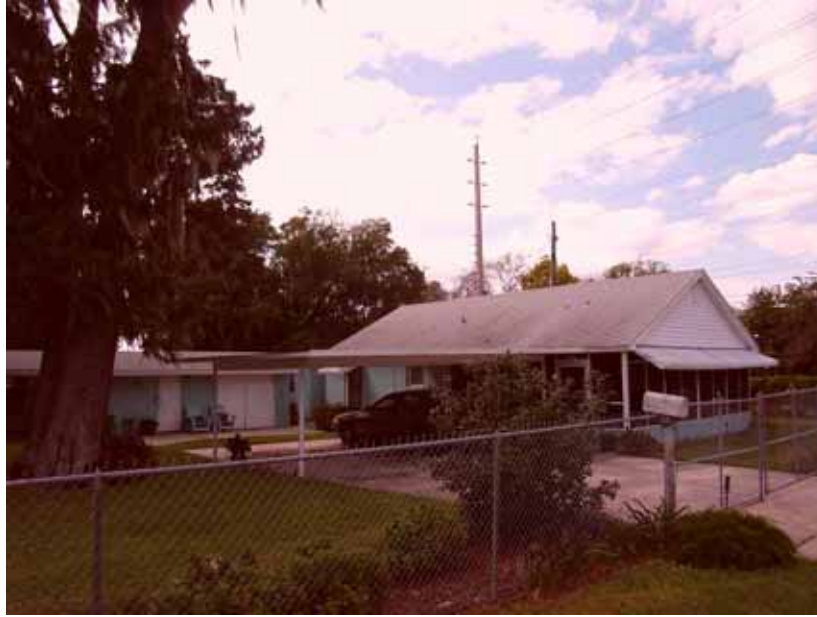
Photo 15. Northeast and southeast elevations of 302 E. Drury Avenue, 8OS2590.

8OS2590: The Masonry Vernacular style residence, at 302 E. Drury Avenue, was constructed ca. 1950 (**Photo 15**). The concrete slab foundation supports the concrete block walls. The house is topped with a gable roof with asphalt shingles. The original windows are jalousie and the replacement windows are two-over-two single hung sash (ca. 1970) and have projecting window sills. An original open porch, located on the northeast elevation was enclosed ca. 1970, and contains the main entrance. There are two ca. 1970 additions on this building, one that wraps around the north and west elevations, and another on the east elevation. Other original architectural features include gable vents, awnings over the enclosed porch, and projecting window sills. Ancillary features include a detached historic garage to the southeast and a shed to the south. Research indicates that this building was not associated with a significant individual or event. In addition, it is an example of a typical Masonry Vernacular style residence found throughout Osceola County and the replacement windows and additions have diminished its integrity. Therefore, 8OS2590 does not appear eligible for listing in the NRHP.

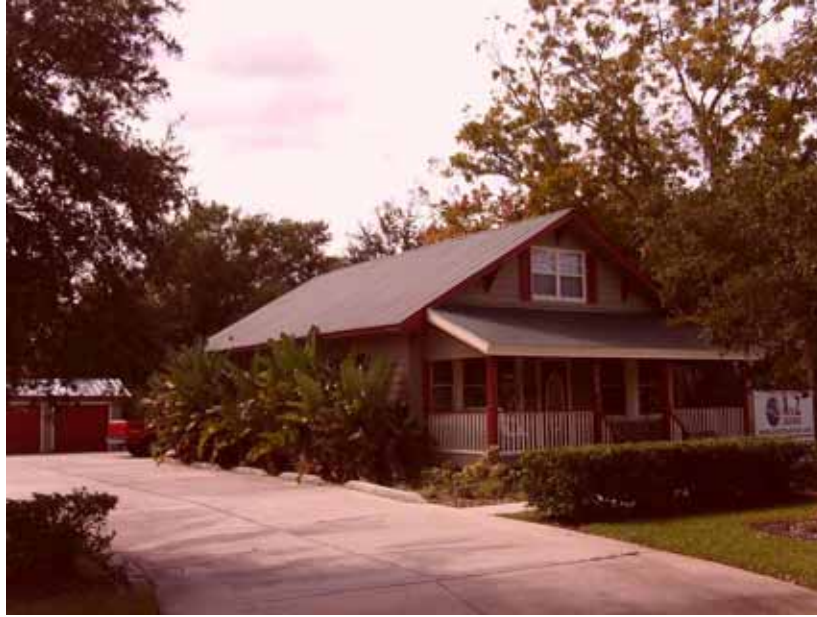
Photo 16. Previously recorded 8OS1950 at 204 E. Drury Avenue, north and west elevations.

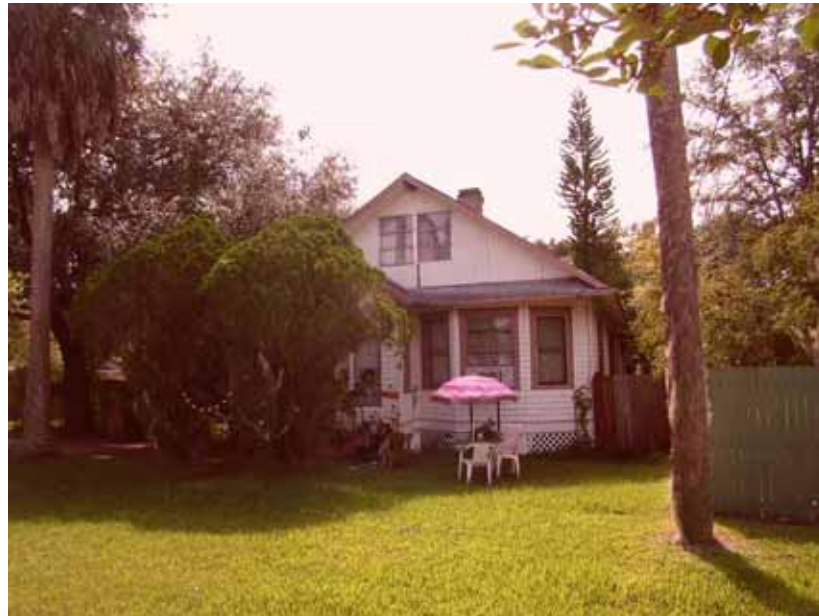
Photo 17. Previously recorded 8OS449 at 210 E. Drury Avenue, east elevation.

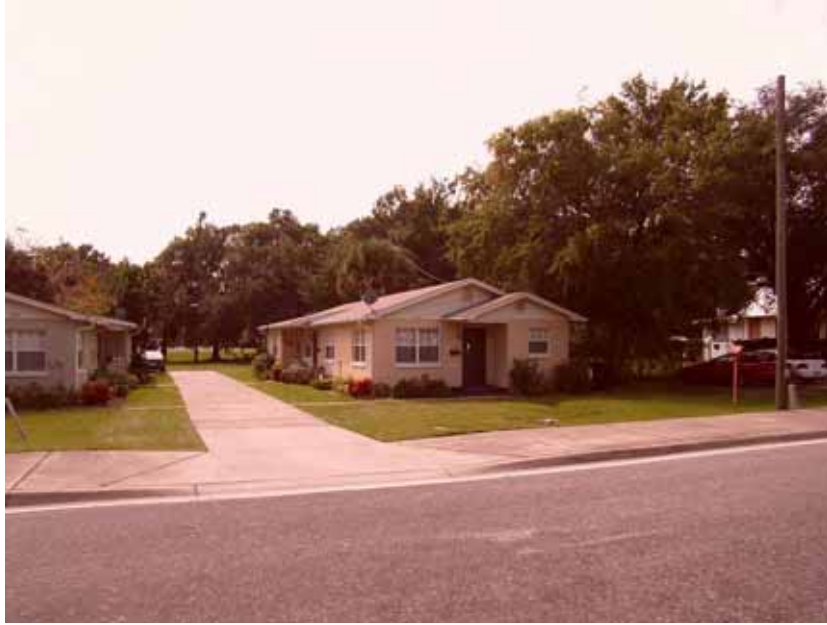
Photo 18. Previously recorded 8OS1954 at 212 E. Drury Avenue, east elevation.

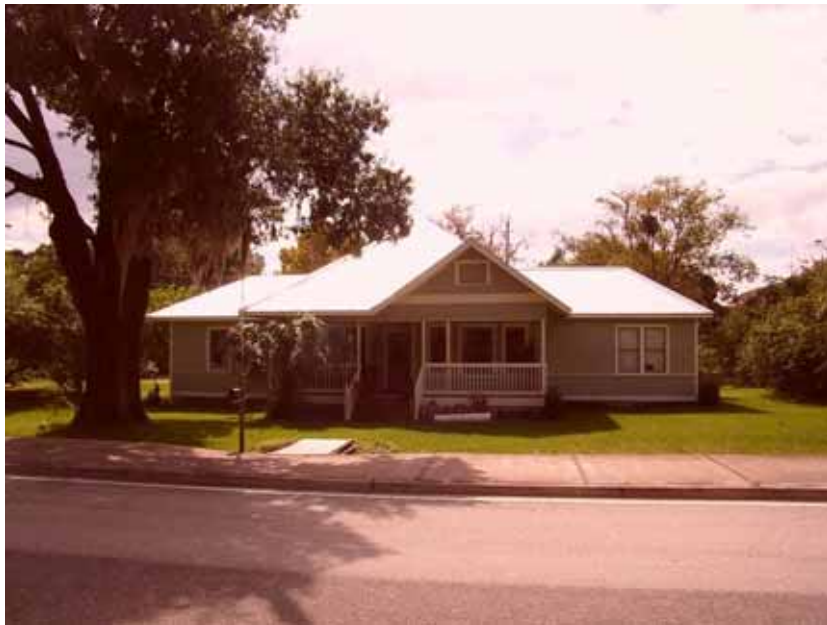
Photo 19. Previously recorded 8OS453 at 216 E. Drury Avenue, east elevation.

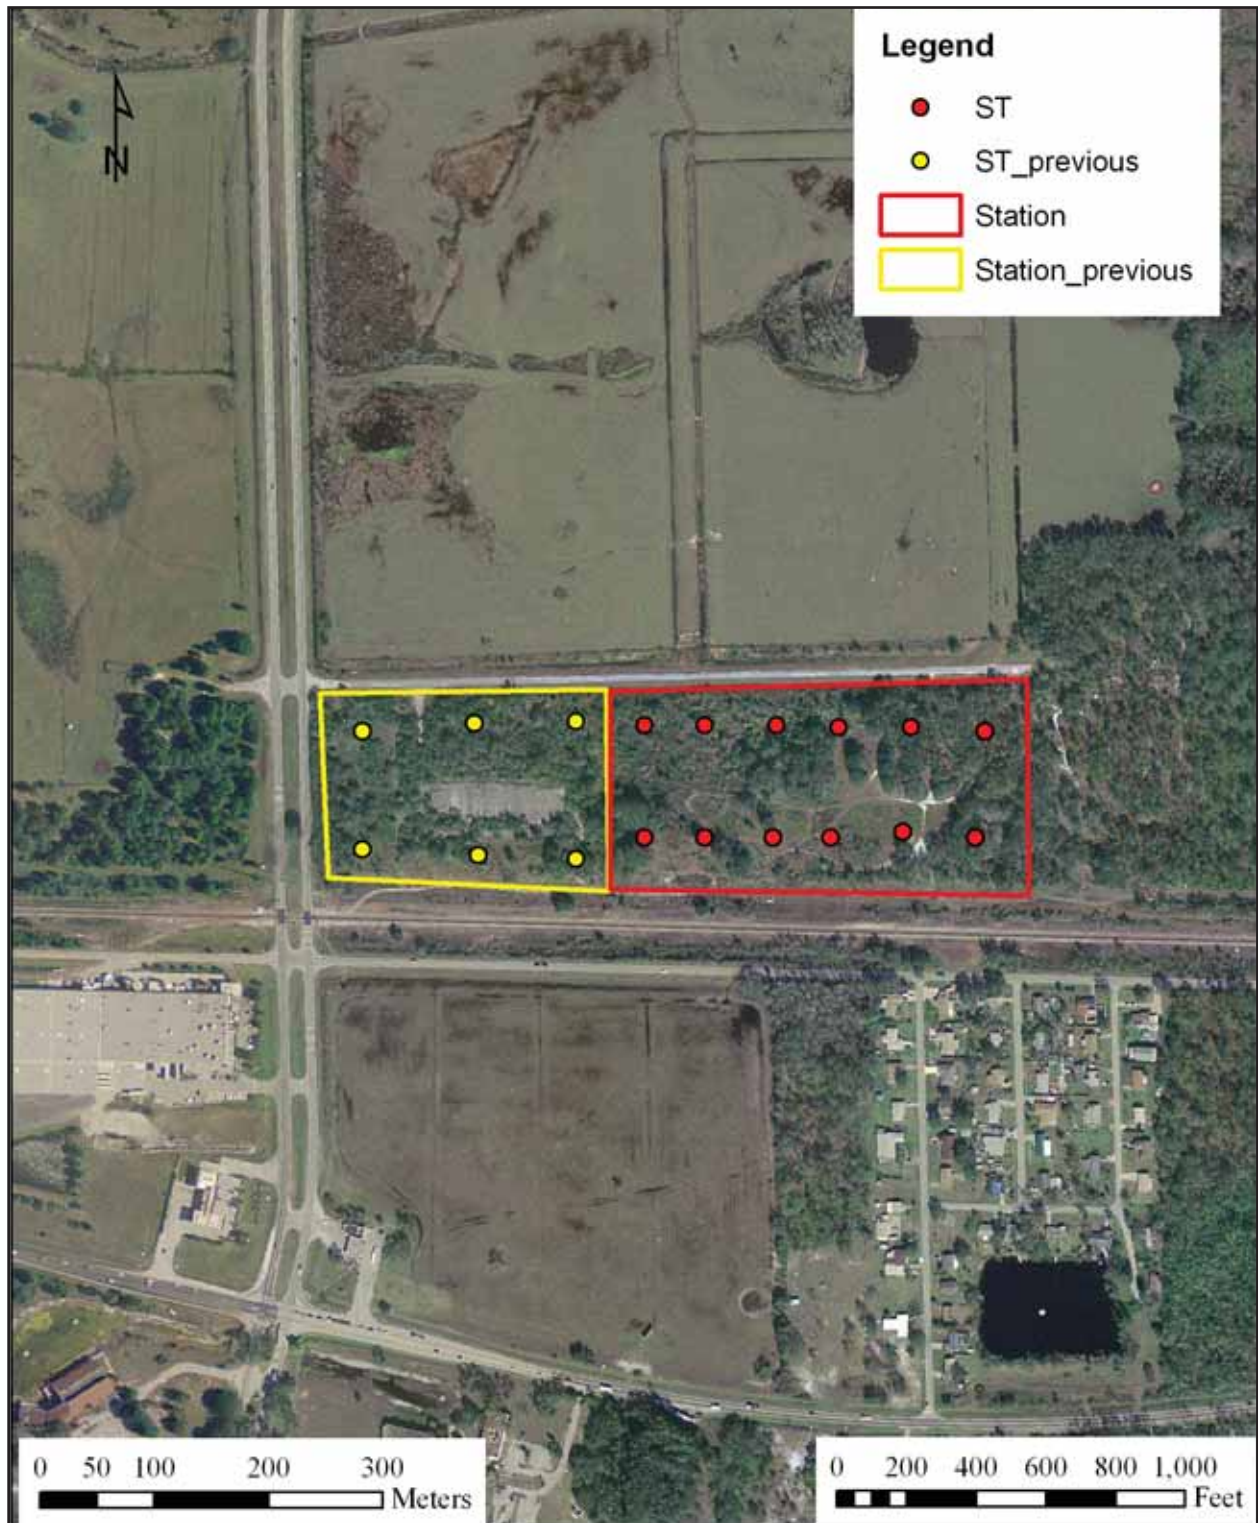
Figure 7. Approximate location of the shovel tests within the proposed Poinciana Industrial Park Station parcels (USGS 2004c).

Archaeological field survey entailed an initial ground surface inspection followed by systematic subsurface testing throughout the parcel (**Figure 7**). Twelve shovel tests were excavated throughout the tract revealing a stratigraphy of 0-20 cm (0-8 in) of gray sand, 20-75 cm (8-30 in) light gray sand, 75-85 cm (30-34 in) dark brown sand, and 85-100 cm (34-39 in) of brown sandy clay. No cultural materials were recovered from the tests or during the surface reconnaissance. No historic resources were identified as the result of historical/architectural field survey.

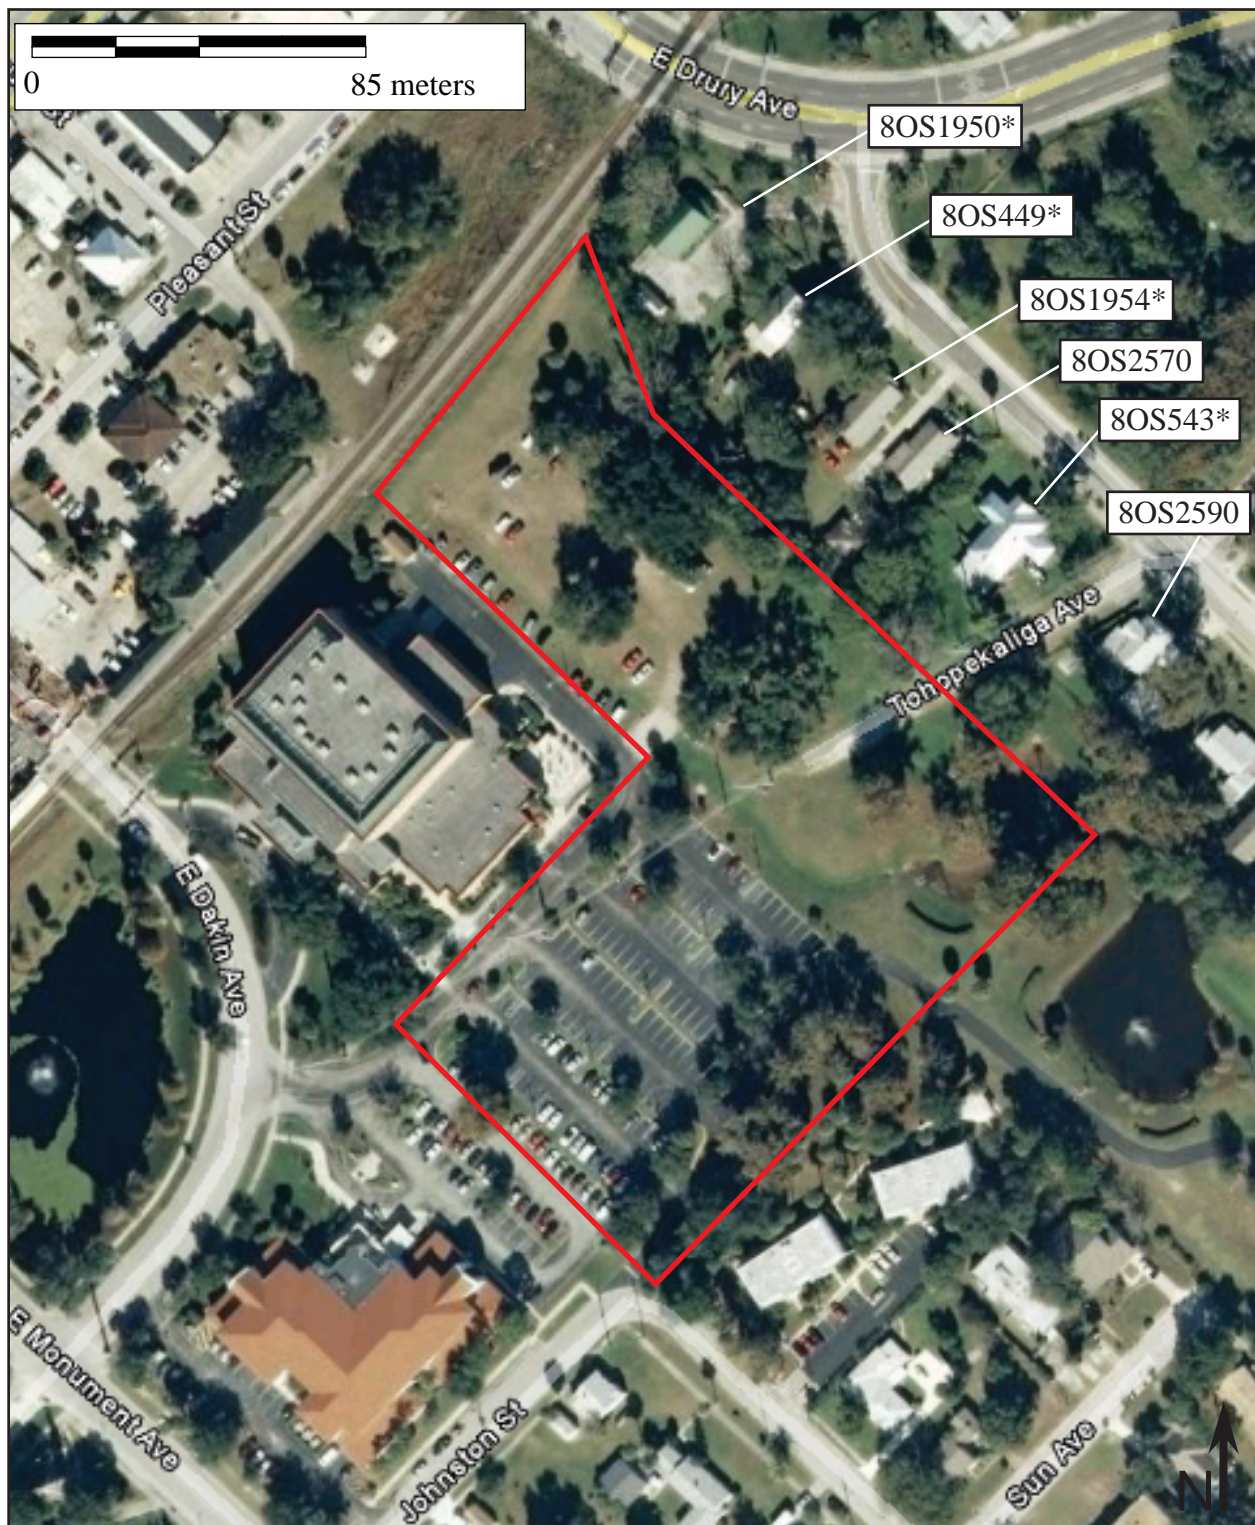
Figure 8. Location of previously and newly recorded historic structures within the proposed Kissimmee Amtrak Station project APE. Previously recorded structures are marked with an asterisk (Google Earth 2009).
