Central Florida Commuter Rail Transit

Cultural Resource Assessment Survey Technical Memorandum

OCTOBER 2009

**CENTRAL FLORIDA COMMUTER RAIL TRANSIT
(SUNRAIL)
SEVEN PROPOSED STATION SITES IN
OSCEOLA, ORANGE, SEMINOLE, AND VOLUSIA COUNTIES,
FLORIDA**

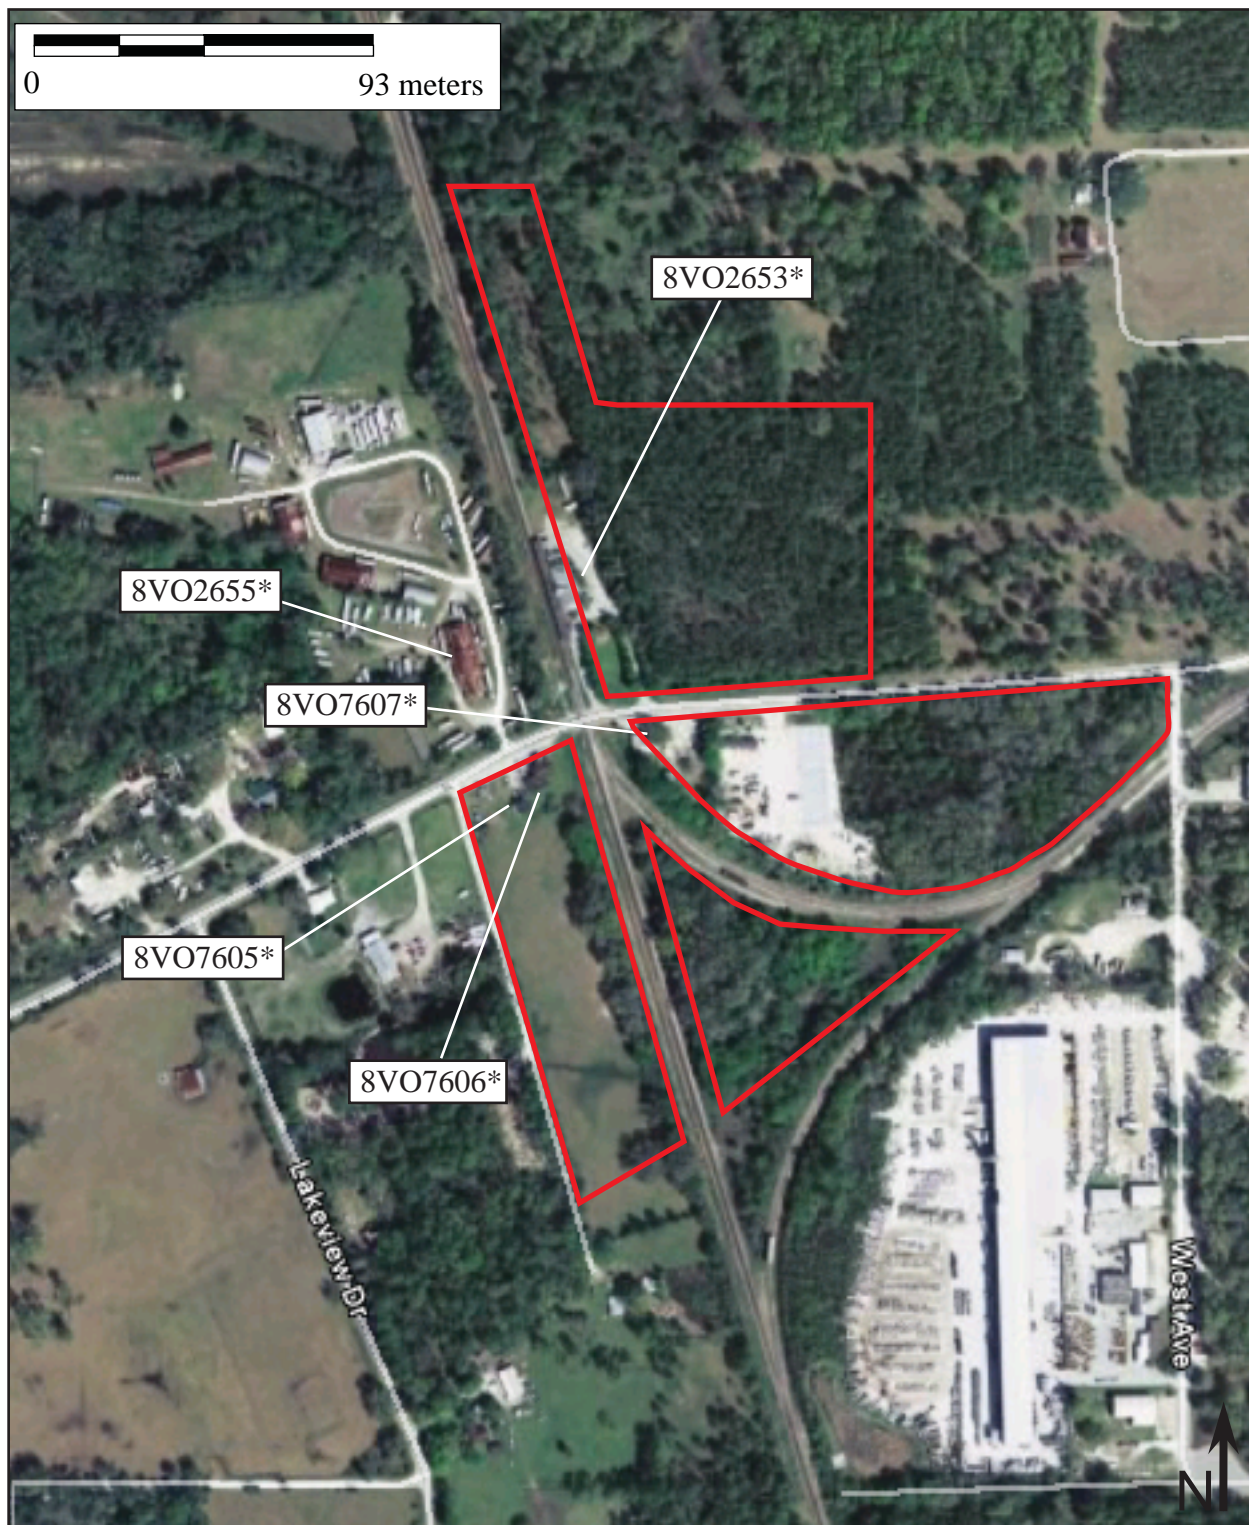
Figure 9. Location of previously and newly recorded historic structures within the proposed Deland Amtrak Station project APE. Previously recorded structures are marked with an asterisk (Google Earth 2009).
