## **Appendix C**

**CENTRAL FLORIDA COMMUTER RAIL TRANSIT (CFCRT)  
FORT FLORIDA ROAD STATION  
VOLUSIA COUNTY, FLORIDA**

**CENTRAL FLORIDA COMMUTER RAIL TRANSIT (CFCRT)  
MAITLAND STATION  
ORANGE COUNTY, FLORIDA**

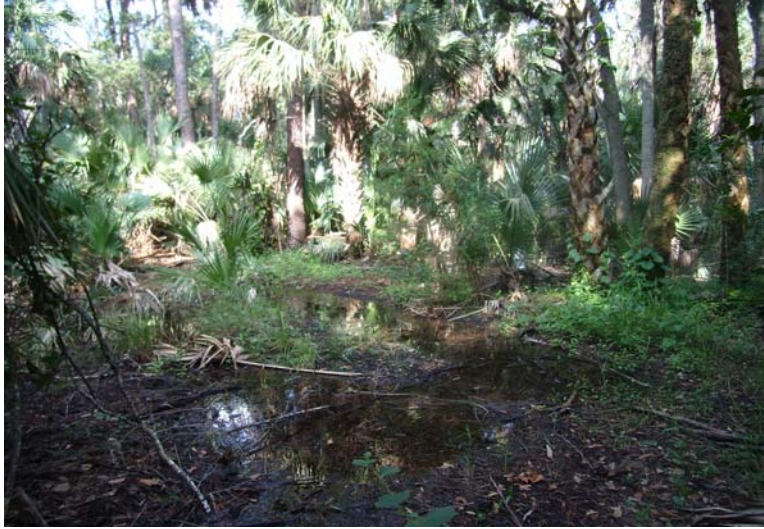
Photo 1. Wet conditions observed in the southern portion of the property.

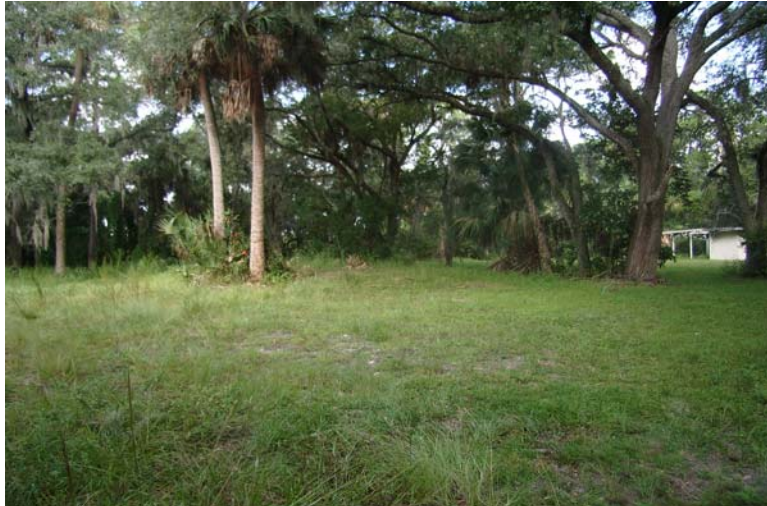
The proposed Fort Florida Road Station property is characterized by soils of the Tomoka muck and EauGallie fine sand types (USDA 1980). The former, a poorly drained type found in swamps and freshwater marshes, is found in the northwest portion of the property. EauGallie fine sand, a nearly level, poorly drained soil found in broad flatwoods, characterizes the remainder of the property. At the time of field survey, most of the southern portion of the property had standing water (Photo 1). Grass and mixed hardwoods vegetate the property (Photo 2).

Photo 2. Vegetation within the Fort Florida Road Station.

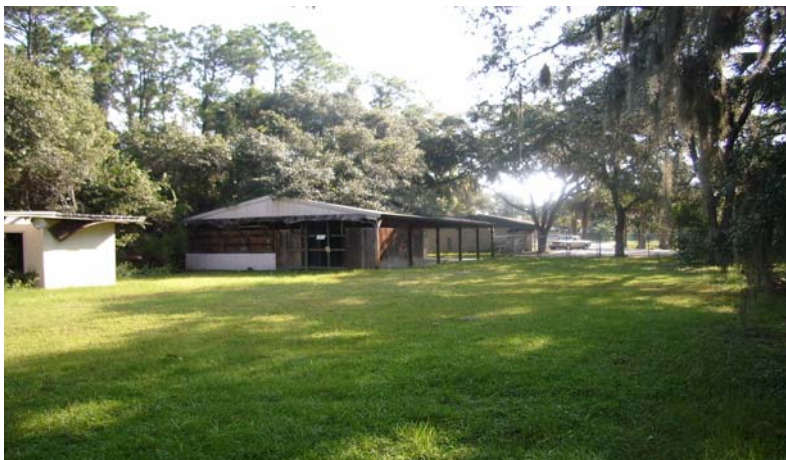
Archaeological field survey entailed an initial ground surface inspection followed by systematic subsurface testing throughout the property. A total of 10 shovel tests were placed systematically at 25 meter (82 foot) intervals along two parallel transects (Figure 1). As a result, no archaeological sites or isolated cultural materials were discovered. In addition, no historic structures were identified within or adjacent to the proposed Fort Florida Road station location. The parcel contains one modern structure (Photo 3).

Photo 3. Modern structure within the northeast portion of the proposed station location.

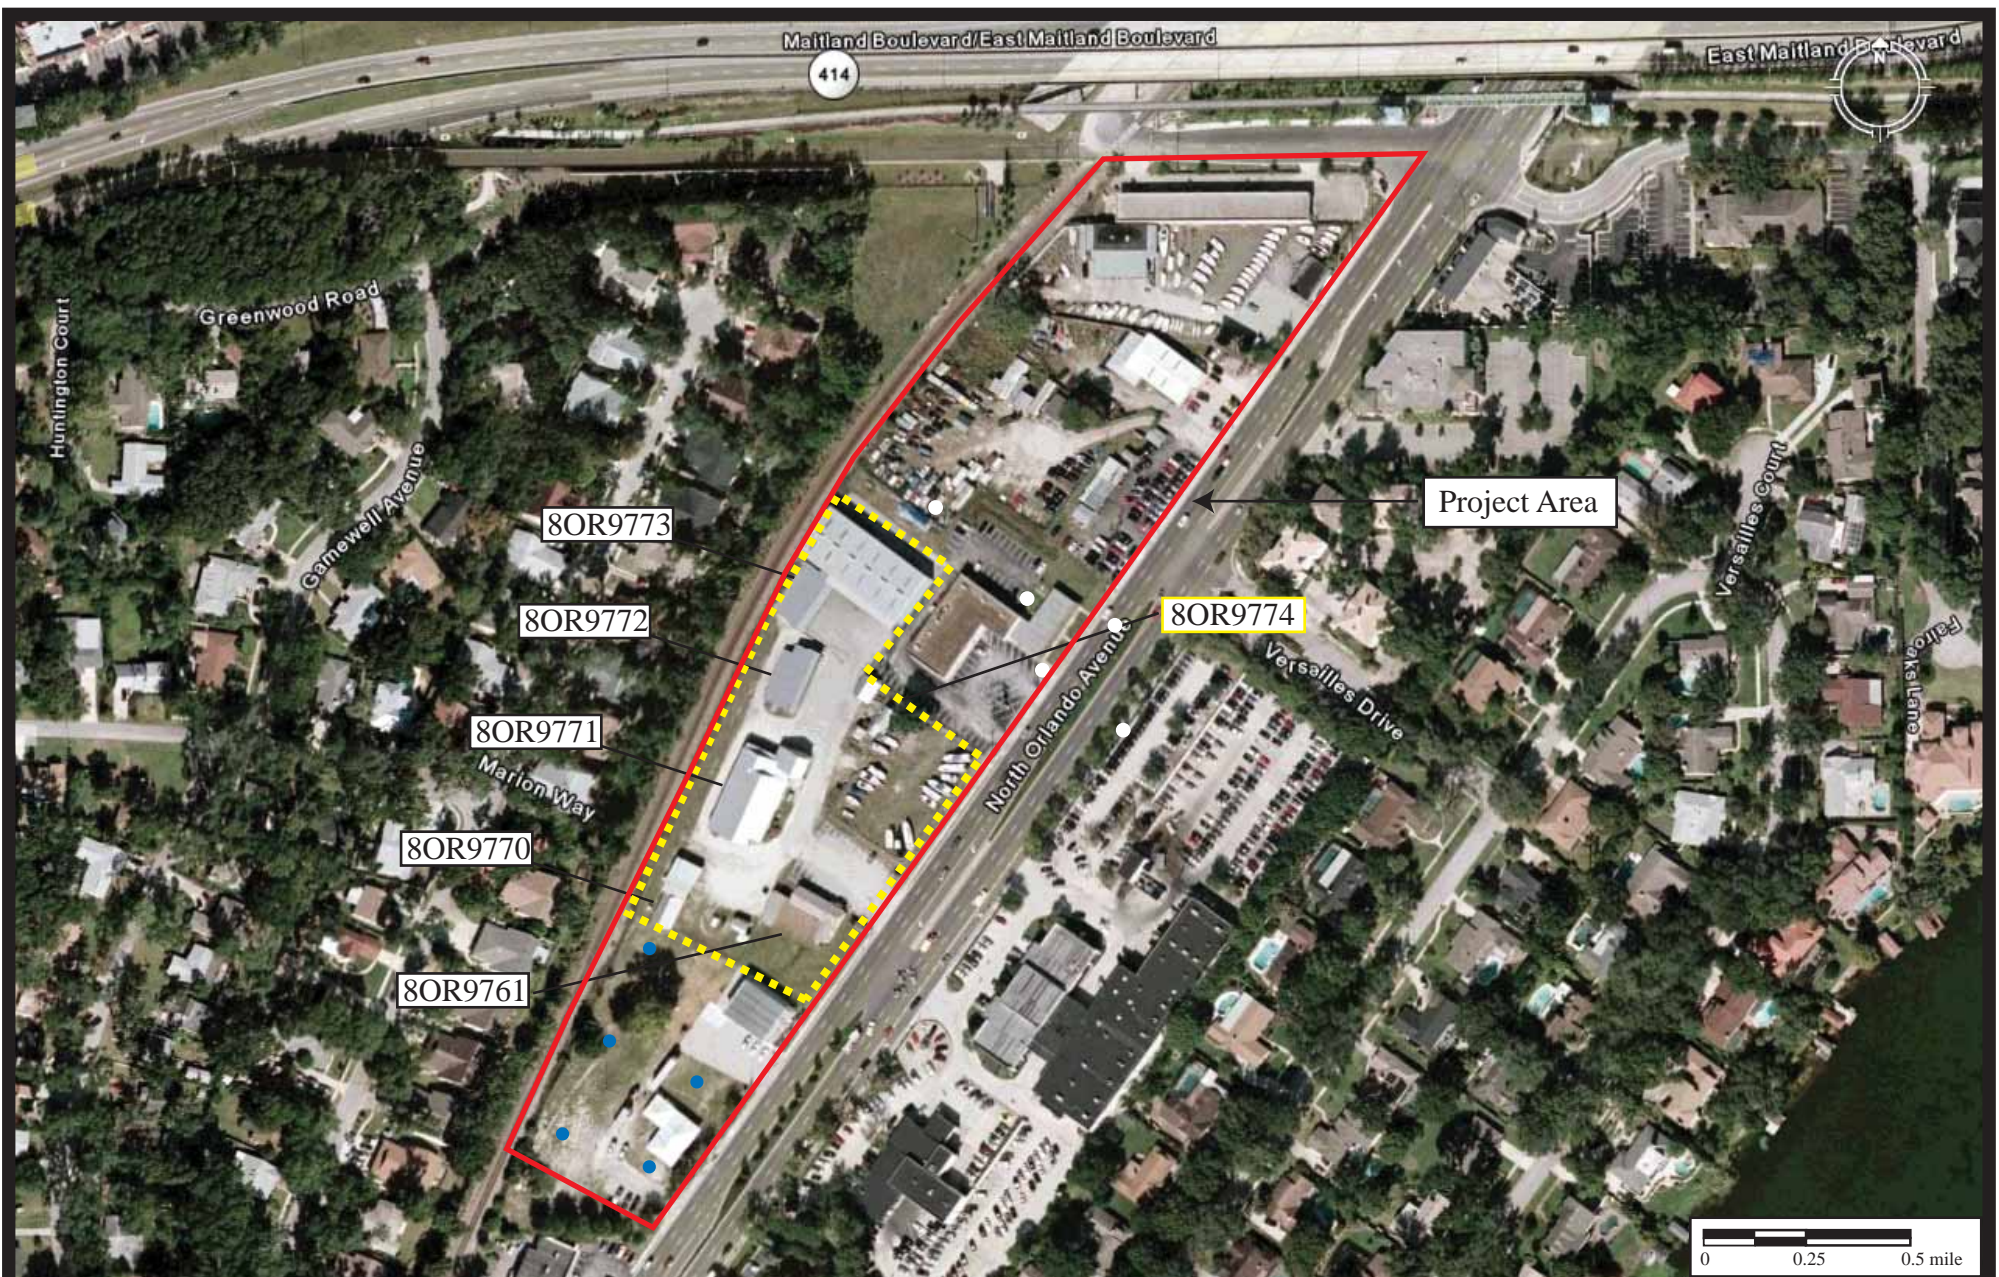
**Figure 1.** Approximate location of shovel tests and historic resources within the project area. Dashed yellow line denotes the Parker Lumber Company resource group. Shovel tests are not to scale.

Five shovel tests were placed systematically at approximate 50 meter (164 foot) intervals in the undeveloped part of the project APE (Figure 1). As a result, no archaeological sites or isolated cultural materials were discovered. Subsurface testing revealed a variable and disturbed stratigraphy. Gravel and other construction materials were observed at depths ranging from 30 cm (12 in) to 100 cm (40 in) in all test pits.

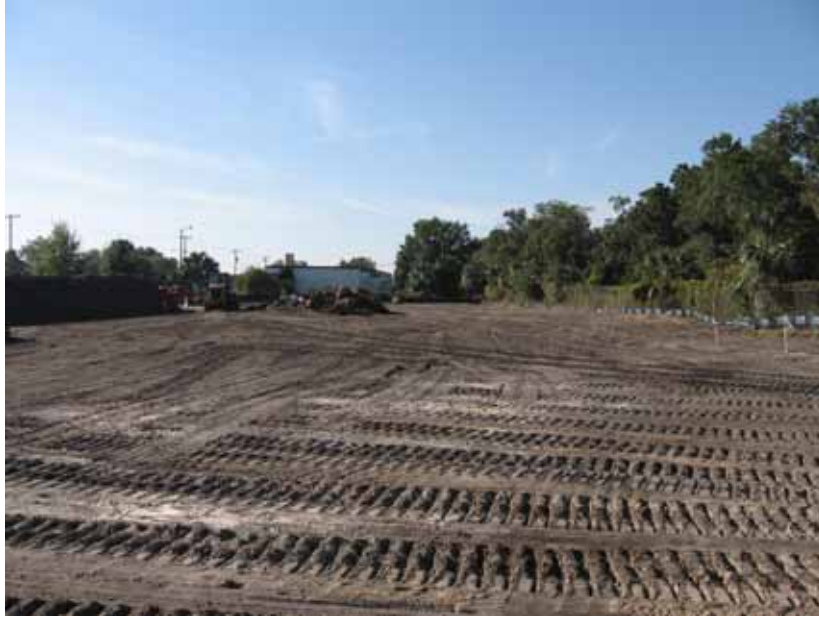
At the time of field survey, an interview with Roebuck Construction employee Shane (surname not provided) indicated that a small concrete structure and accompanying driveway and utilities had been removed from the southwest corner of the parcel. Prior to their site preparation work (in progress), the parcel was used as a pasture with a watering well (Roebuck Construction 2007). Existing conditions at the time of archaeological field survey are shown in Photos 1 and 2.

**Photo 1.** Existing Conditions, December 7, 2007, looking south.

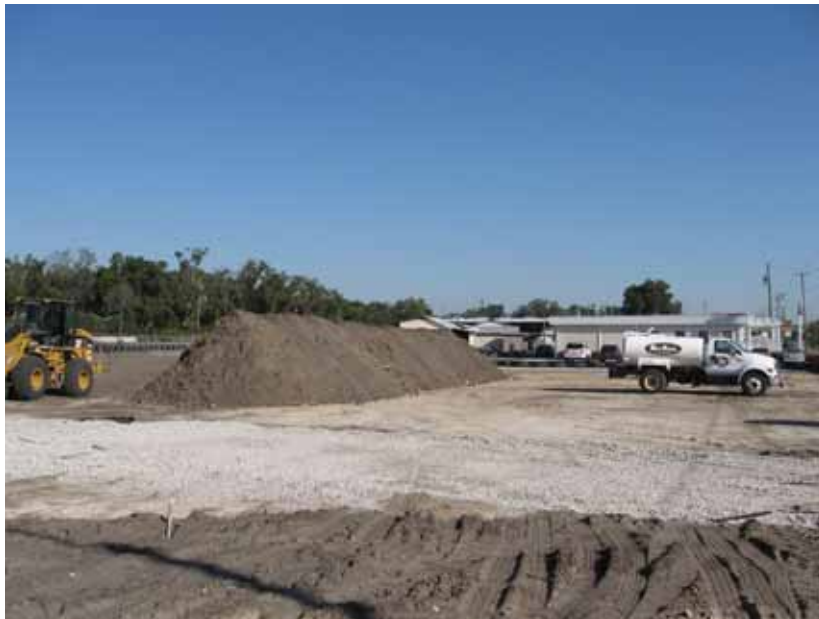
**Photo 2.** Existing Conditions, December 7, 2007, looking north.

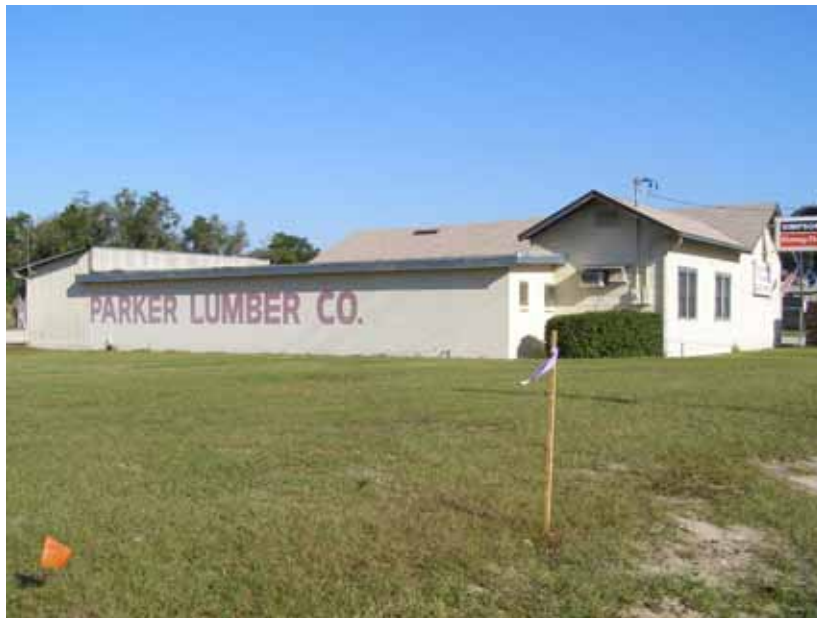
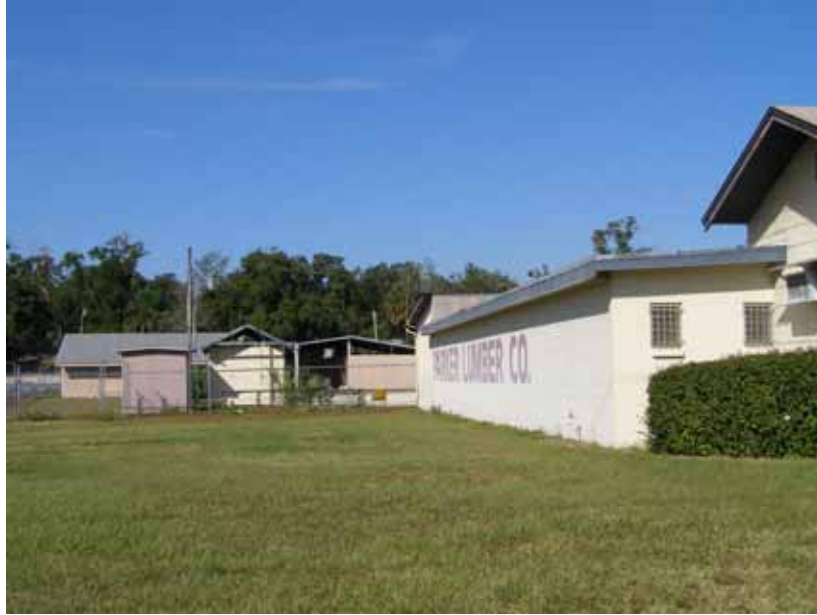
**Photo 3.** Looking southwest towards the Parker Lumber Company Resource Group (8OR9774).

**Photo 4.** Looking west towards the Parker Lumber Company Resource Group (8OR9774).

**8OR9774:** The Parker Lumber Company Resource Group (Photos 3 and 4) consists of one previously recorded resource, 8OR9761, four newly identified historic structures, 8OR9770 – 8OR9773, and three non-contributing ancillary structures. The total five Frame Vernacular style buildings were constructed ca. 1934 to ca. 1953. They are currently being used as an office, storage and warehouses for the Parker Lumber Company. W.L. Parker, Sr., born in Middlefield, Ohio; first established the company in the Kissimmee area ca. 1909 (Parker Lumber Company 2007). Ten years later, he moved to Maitland to found the Maitland Lumber Company, which later became known as the Parker Lumber Company (*Orlando Sentinel* 1986; Polk 1935). Originally, the Parker Lumber Company spanned both sides of the railroad. The business operations included all lumber activities from cutting raw timber to preparing the timber for market. Building 3 (8OR9771) once housed the machinery (e.g., the planer, kiln, and the boiler engine) that was used to process the timber. Adjacent to this building was a water tower that supplied the boiler engine. The company has remained in the Parker family and is now owned by three brothers, the fourth generation to operate the business. The water tower and the machinery are no longer extant. The company maintains an on-site wholesale and retail business (Parker Lumber Company 2007). Although the Parker Lumber Company is historically linked to the development of central Florida's lumber industry during the early 1900s, it is not considered potentially NRHP eligible. Each of the contributing buildings has undergone numerous additions and alterations, thus compromising the architectural integrity of the resource group. Therefore, 8OR9774 is not considered potentially eligible for listing in the NRHP, at the local or state level.

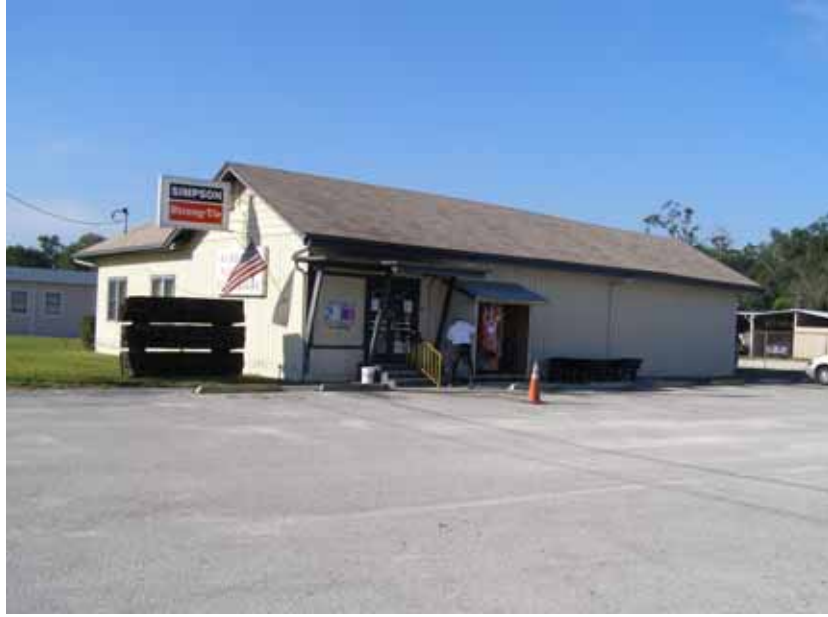
**Photo 5.** North and east elevations of 851 N. Orlando Avenue, 8OR9761.

**8OR9761:** This Frame Vernacular style commercial building (Photo 5), located at 851 N. Orlando Avenue, was constructed ca. 1934. It is used as an office and retail store for the Parker Lumber Company. 8OR9761 was previously recorded in 2005 as part of the CRAS for the CFCRT EA (ACI 2005), and determined ineligible for listing in the NRHP by the Florida SHPO. It is now included as part of the Parker Lumber Company Resource Group (8OR9774). The building retains its appearance from the time it was originally recorded. The wood frame walls are clad in vertical siding and concrete block (ca. 1995). The complex roof is in the cross gable, flat, and shed styles and is covered in composition roll (ca. 1995). Windows are paired, one over one (1/1) double hung sash (DHS) with wood surrounds, and the main entrance is located on the north via an open porch with a flat roof and cantilevered posts. A ca. 1960 concrete block addition is on the south and a ca. 1975 wood frame addition is on the east. In concurrence with the 2005 assessment, 8OR9761 is not considered potentially eligible for listing in the NRHP either individually or collectively as part of the Parker Lumber Company Resource Group (8OR9774).

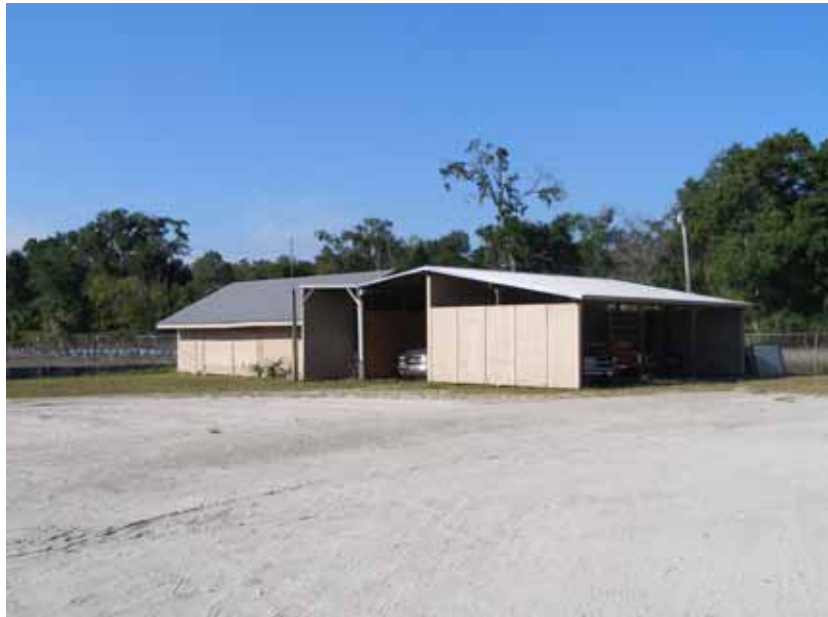
**Photo 6.** North and east elevations of Building 2 (8OR9770) of the Parker Lumber Company Resource Group (8OR9774).

**8OR9770:** Building 2 of the Parker Lumber Company Resource Group is a ca. 1935 Frame Vernacular style commercial structure (Photo 6). It is currently used as a storage facility for the Parker Lumber Company. The wood frame walls rest on a concrete block pier and slab foundation and are covered in clapboard and replacement plywood sheeting. The gable and shed roof is faced in 5-V crimp metal sheeting (ca. 1970s). The building also features exposed rafters. A large garage/shed addition (ca. 1970s) is on the north elevation, and two ancillary sheds are located to the south. Although this building is associated with the Parker Lumber Company, an example of local early 20<sup>th</sup> century commercial enterprise, it is a typical Frame Vernacular style building with no distinguishing features or characteristics. Also, alterations like the replacement siding and roof and the north addition compromise its architectural integrity. Therefore, 8OR9770 is not considered potentially eligible for listing in the NRHP at the local or national level either individually or collectively as part of the Parker Lumber Company Resource Group (8OR9774).

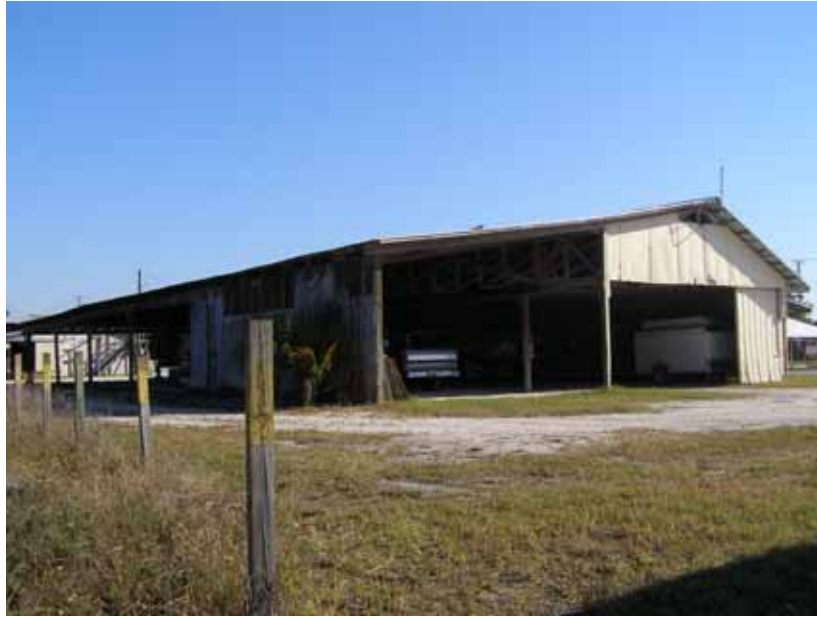
**Photo 7.** South and west elevations of Building 3 (8OR9771) of the Parker Lumber Company Resource Group (8OR9774).

**8OR9771:** Building 3 of the Parker Lumber Company Resource Group is a Frame Vernacular style commercial building (Photo 7) constructed ca. 1936. It is currently used as a warehouse for the Parker Lumber Company. A continuous and pier foundation of concrete block supports the wood frame walls covered in clapboard, replacement plywood sheeting (ca. 1970s), vertical board (ca. 1980s), and 3-V crimp metal sheeting. The gable and shed roof is faced in 5-V crimp metal sheeting (ca. 1980s). Other architectural features include exposed rafters. Two shed additions and a screened-in porch addition are on the east. Another large addition is to the north. It is connected via an open hyphen. An ancillary shed is located to the southeast. An interview with an employee of the Parker Lumber Company revealed that this building once housed machinery used to prepare timber for market, including a kiln, planer, and a boiler engine. The water tower that provided water to the engine was originally located adjacent to this building (Parker Lumber Company 2007). The machinery and water tower are no longer extant. This building is associated with the Parker Lumber Company, an example of local early 20<sup>th</sup> century commercial enterprise; however, it is a typical Frame Vernacular style building used as a warehouse. Numerous alterations and additions, and the removal of some of the building's original machinery, diminish the building's individual significance and architectural integrity. Therefore, 8OR9771 is not considered potentially eligible for listing in the NRHP at the local or national level either individually or collectively as part of the Parker Lumber Company Resource Group (8OR9774).

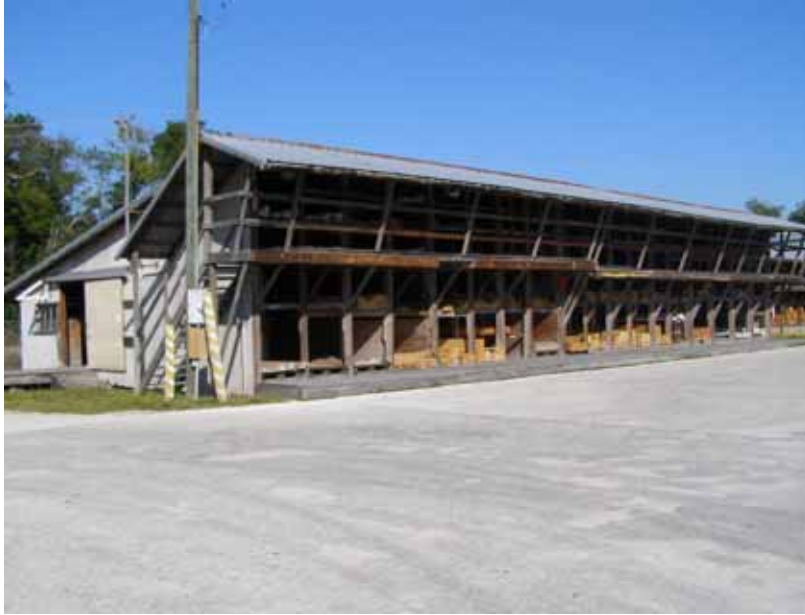
**Photo 8.** South and east elevations of Building 4 (8OR9772) of the Parker Lumber Company Resource Group (8OR9774).

**8OR9772:** Building 4 of the Parker Lumber Company Resource Group is a ca. 1935 Frame Vernacular style building (Photo 8). It is currently used as a warehouse for the Parker Lumber Company. A concrete block pier foundation supports the wood frame walls covered in clapboard and replacement plywood sheeting, vertical board (ca. 1980s), and 3-V crimp metal sheeting. The gable and shed roof is faced in replacement 5-V crimp metal sheeting (ca. 1970s). Other architectural features include exposed frame and rafters, an external staircase to the second level, a loading area on the west, and barn doors. A shed addition is on the west elevation, and an ancillary shed is to the southeast. Although this building is associated with the Parker Lumber Company, an example of local early 20<sup>th</sup> century commercial enterprise, it is a typical Frame Vernacular style building with no distinguishing features or characteristics. Also, alterations such as the replacement roof and siding and the shed addition compromise its architectural integrity. Therefore, 8OR9772 is not considered potentially eligible for listing in the NRHP at the local or national level either individually or collectively as part of the Parker Lumber Company Resource Group (8OR9774).

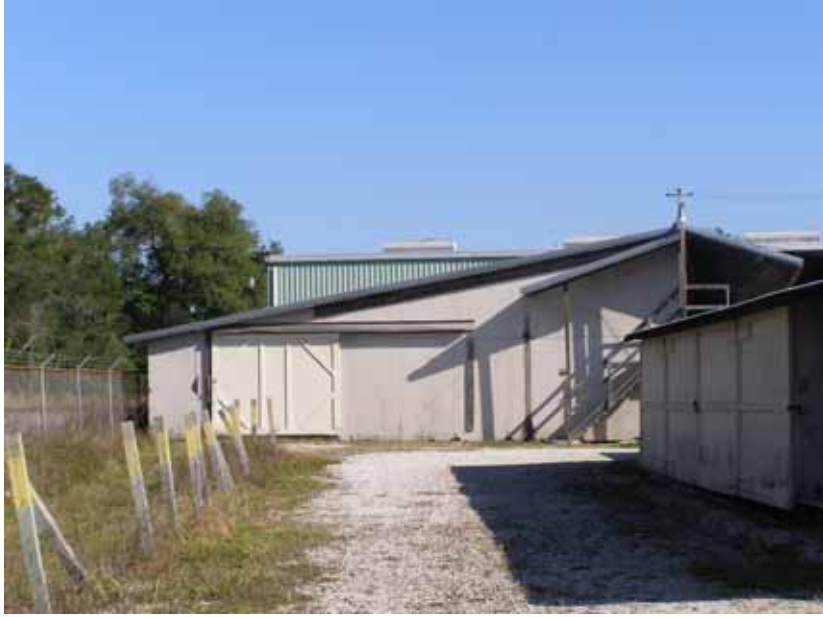
**Photo 9.** South elevation of Building 5 (8OR9773) of the Parker Lumber Company Resource Group (8OR9774).

**8OR9773:** Building 5 of the Parker Lumber Company Resource Group is a ca. 1953 Frame Vernacular style building (Photo 9). It is used as a warehouse for the Parker Lumber Company. A concrete block pier and slab foundation supports the wood frame walls covered in clapboard, replacement plywood sheeting, vertical board (ca. 1980s), and 3-V crimp metal sheeting. The gable and shed roof is faced in replacement 5-V crimp metal sheeting (ca. 1980s). Other architectural features include exposed frame and rafters, an external staircase to the second level, a loading area, and barn doors. A shed addition is on the west elevation and a large warehouse addition is on the north (both ca. 1970s). Although this building is associated with the Parker Lumber Company, an example of local early 20<sup>th</sup> century commercial enterprise, it is a typical Frame Vernacular style building with no distinguishing features or characteristics. Also, alterations such as the replacement roof and siding and the shed addition compromise its architectural integrity. Therefore, 8OR9773 is not considered potentially eligible for listing in the NRHP at the local or national level either individually or collectively as part of the Parker Lumber Company Resource Group (8OR9774).

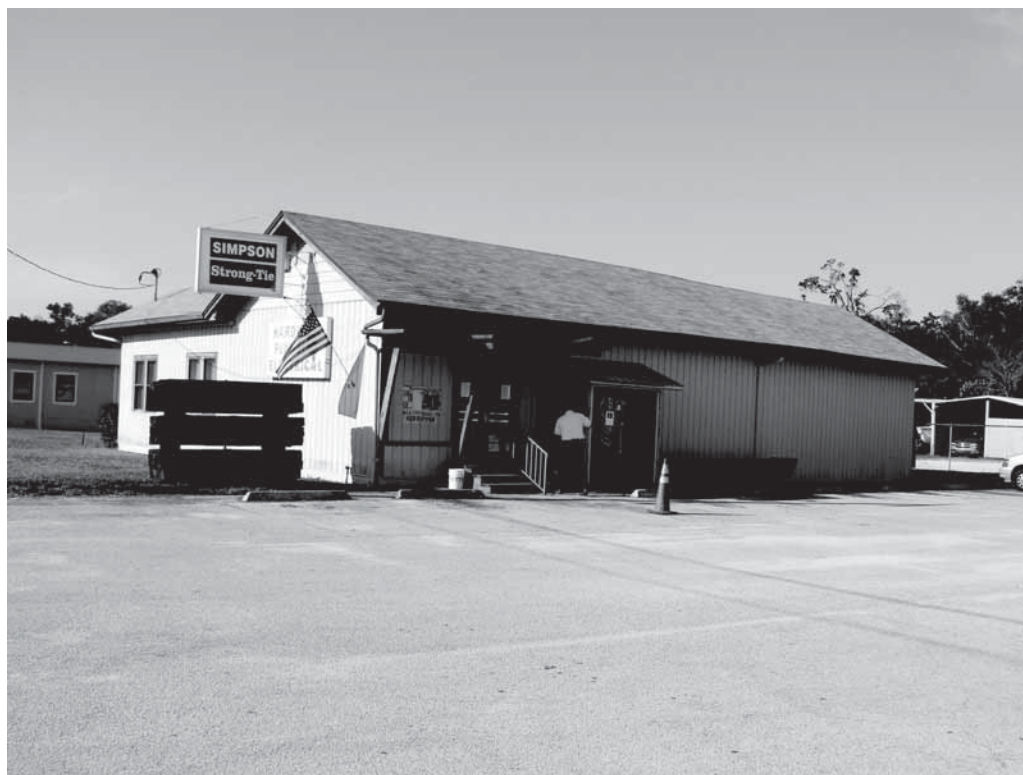
**PHOTOGRAPH**

Condition (overall resource condition): ☐ excellent ☐ good ☒ fair ☐ deteriorated ☐ ruinousNarrative Description of Resource This building is part of the Parker Lumber Co. Resource Group (8OR9774).Archaeological Remains \_\_\_\_\_ ☐ Check if Archaeological Form Completed\* Consult *Guide to Historical Structure Forms* for preferred descriptions (coded fields at the Site File).

Explanation of Evaluation (required, whether significant or not; use separate sheet if needed) This is a typical Frame Vernacular style building with no distinguishing features or characteristics. Also, alterations like the change in cladding and the replaced roof, and additions like the north shed/garage compromise its integrity. Therefore, 8OR9770 is not potentially eligible for listing in the NRHP, either individually or collectively.

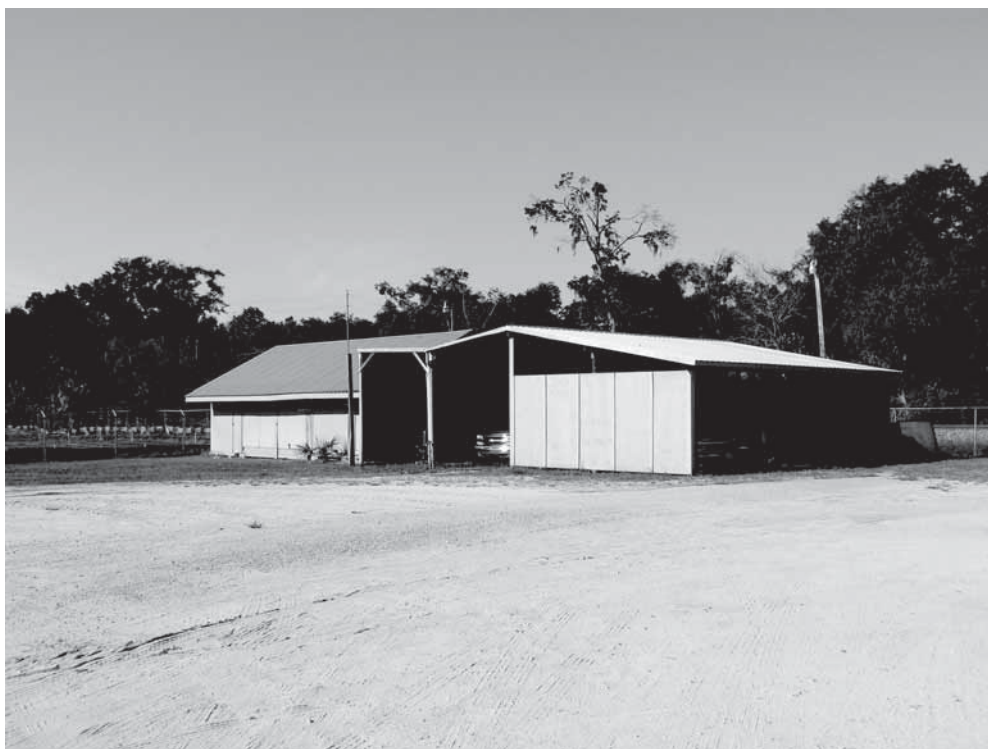
**PHOTOGRAPH**

Porch Descriptions (types, locations, roof types, etc.) open hyphen, gableCondition (overall resource condition): ☐ excellent ☐ good ☒ fair ☐ deteriorated ☐ ruinousNarrative Description of Resource This building is part of the Parker Lumber Co. Resource Group (8OR9774).Archaeological Remains \_\_\_\_\_ ☐ Check if Archaeological Form Completed\* Consult *Guide to Historical Structure Forms* for preferred descriptions (coded fields at the Site File).

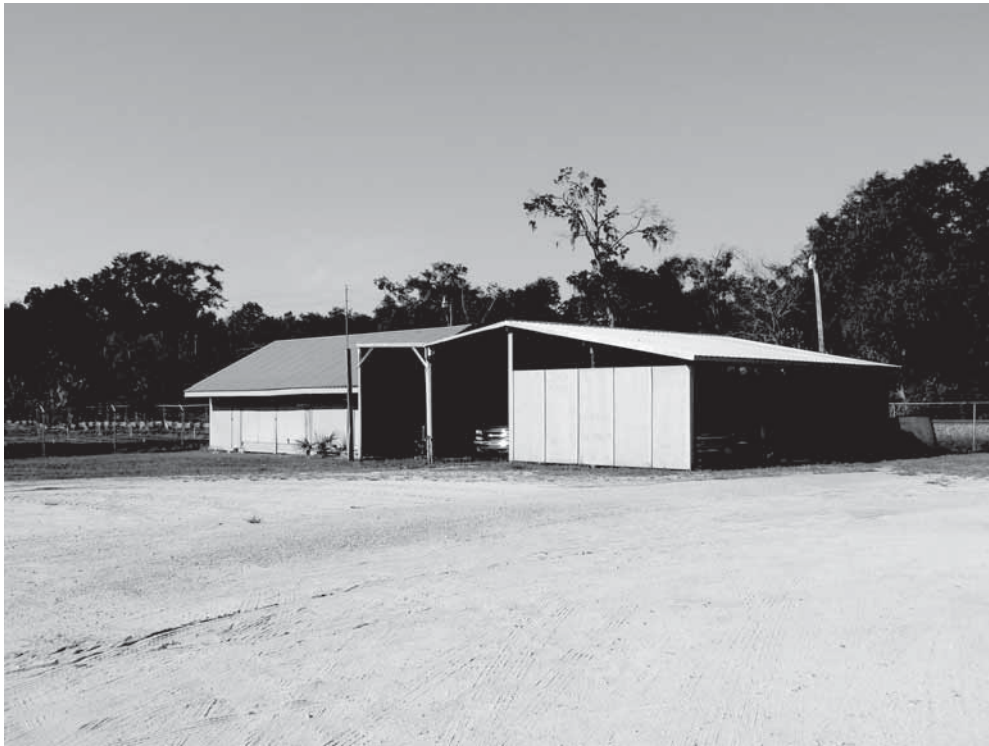
**PHOTOGRAPH**

Condition (overall resource condition): ☐ excellent ☐ good ☒ fair ☐ deteriorated ☐ ruinousNarrative Description of Resource This building is part of the Parker Lumber Co. Resource Group (8OR9774).Archaeological Remains \_\_\_\_\_ ☐ Check if Archaeological Form Completed\* Consult *Guide to Historical Structure Forms* for preferred descriptions (coded fields at the Site File).

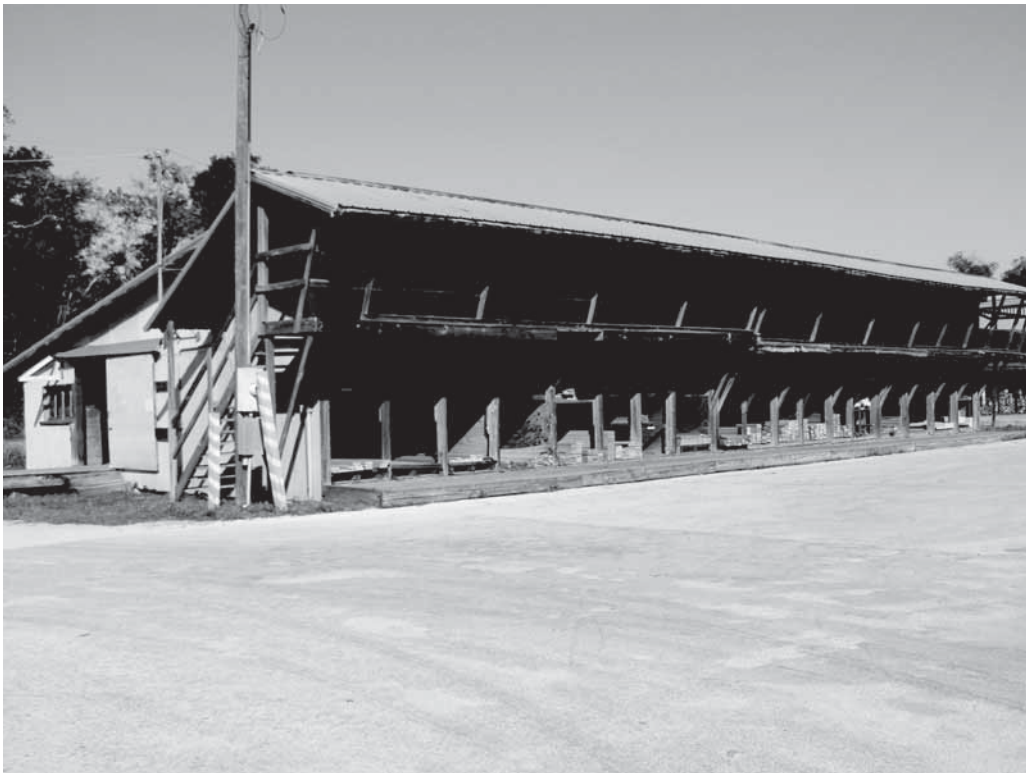
**PHOTOGRAPH**

Condition (overall resource condition): ☐ excellent ☐ good ☒ fair ☐ deteriorated ☐ ruinousNarrative Description of Resource This building is part of the Parker Lumber Co. Resource Group (8OR9774).Archaeological Remains \_\_\_\_\_ ☐ Check if Archaeological Form Completed\* Consult *Guide to Historical Structure Forms* for preferred descriptions (coded fields at the Site File).

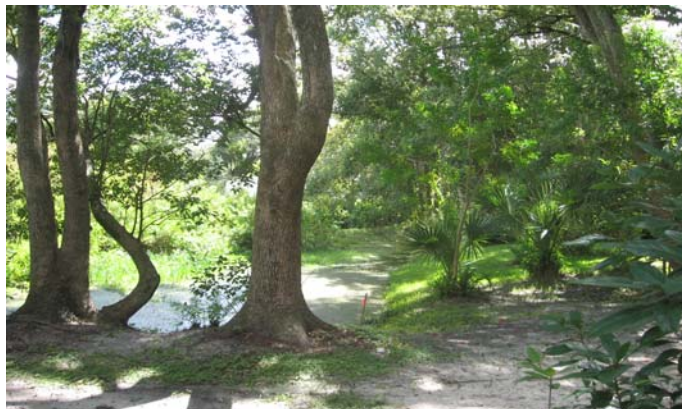
Photo 1. Wetland located in the northern parcel.

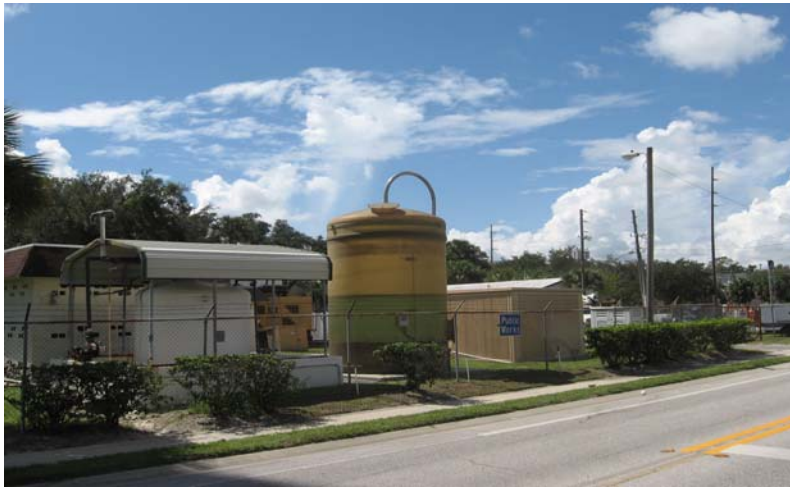
Photo 2. Parcel located just east of Longwood Street.

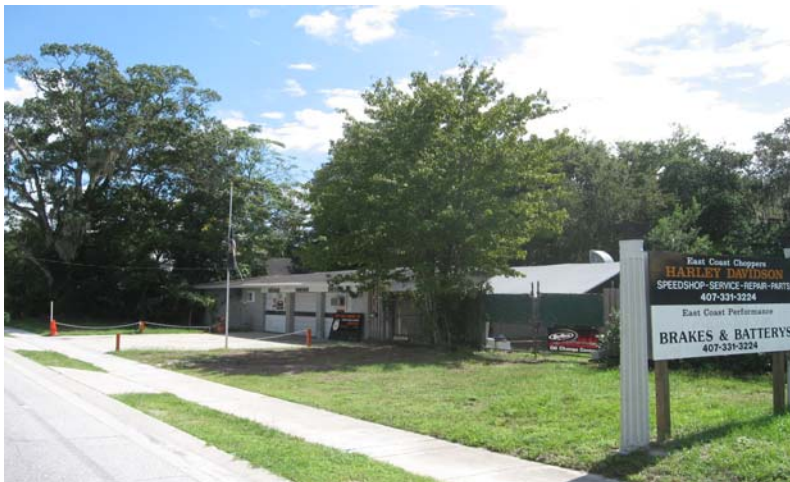
Photo 3. Parcel situated east of Myrtle Street.

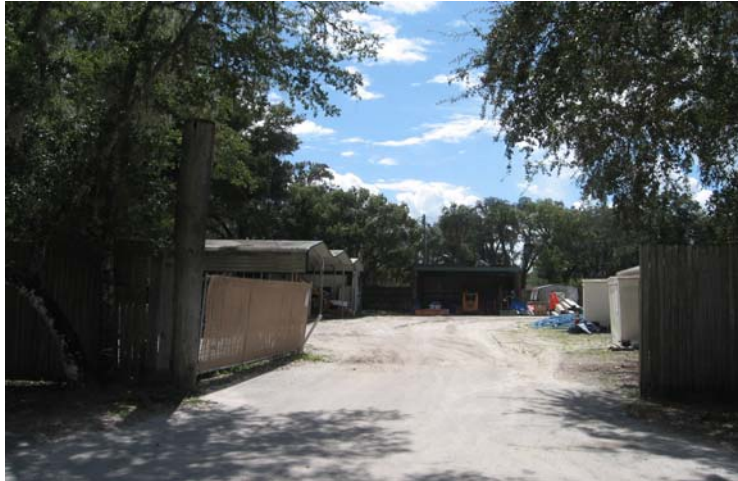
Photo 4. Parcel located south of Warren Avenue.

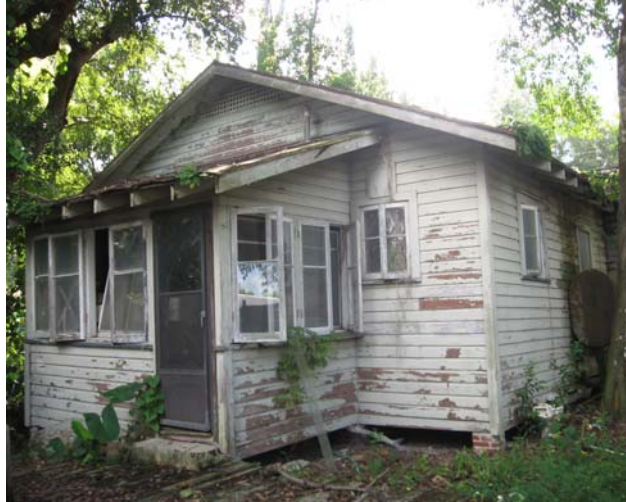
Architectural/historical field survey resulted in the location of one historic resource, 8SE2339 (Figure 1). This Frame Vernacular residence was constructed ca. 1935 at 217 East Warren Street (Photo 5). Its wood frame walls, faced with wood drop siding, rest on a brick pier foundation. The cross-gable and shed roofs are covered with 3-V crimp metal sheeting, and there are two brick chimneys at the ridge line. Original windows consist of six-light over one-light double hung sash and two-light wood casements. An enclosed porch sits on the north elevation, and a second porch, housing the main entrance, is located on the south elevation. It was enclosed ca. 1950, and contains a wood swing door and metal sliding windows. Exterior ornamentation includes wood window and door surrounds, lattice-work gable vents, cornerboards and exposed rafter tails. This is a common example of a Frame Vernacular style structure, and research revealed no significant historical associations. Therefore, 8SE2339 does not appear eligible for listing in the NRHP.

Photo 5. 217 East Warren Street, facing southeast

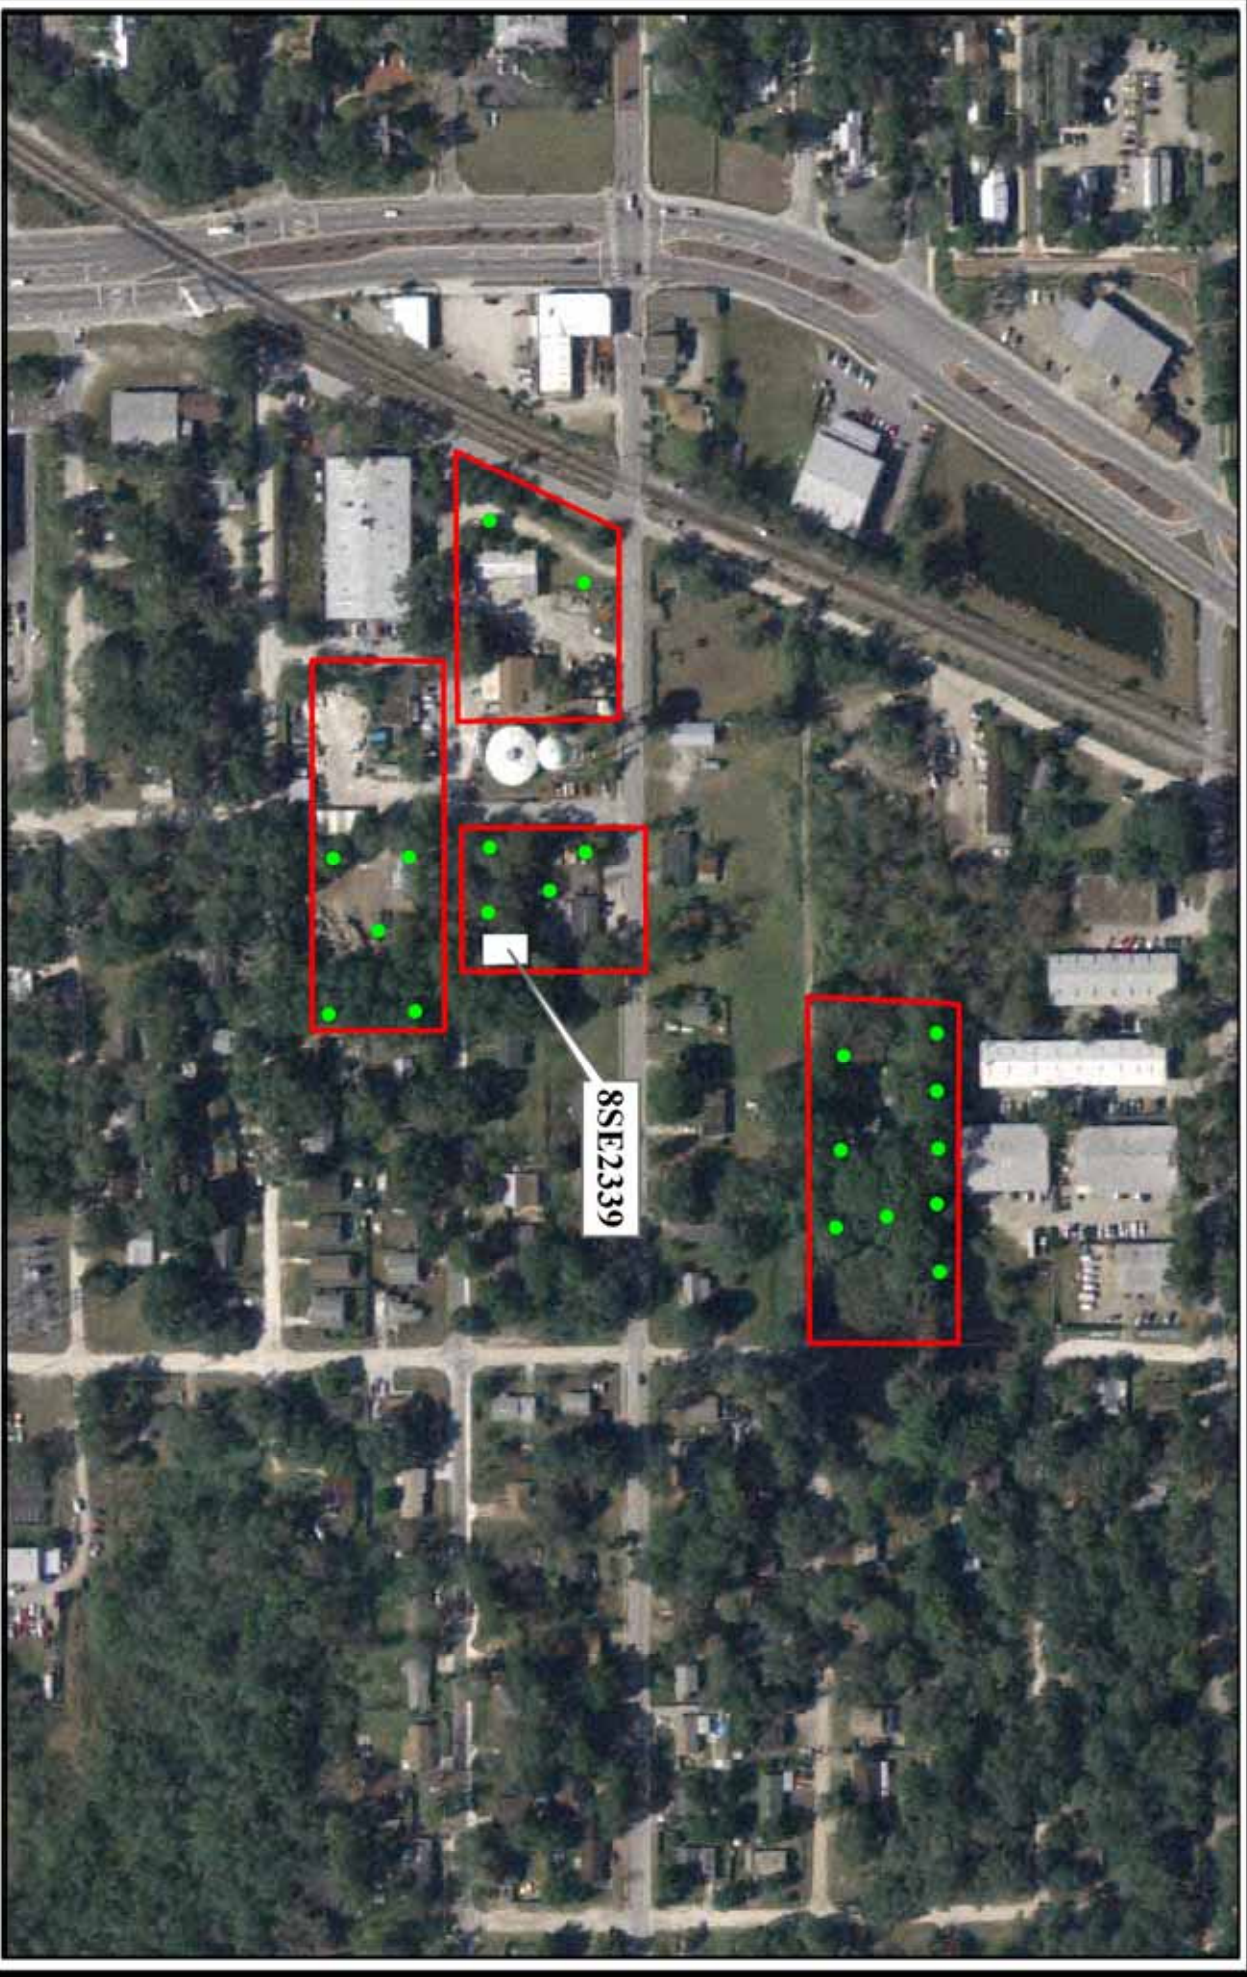
Archaeological field survey entailed an initial ground surface inspection followed by systematic and judgmental subsurface testing throughout the four parcels. Nine shovel tests were placed systematically at 50 meter (164 foot) intervals in the northern most parcel. An additional 11 shovel tests were placed judgmentally in the remaining three parcels (Figure 1). As a result, no archaeological sites or isolated cultural materials were discovered.

**Figure 1.** Approximate location of shovel tests and newly recorded historic resource (8SE2339) within the proposed Longwood Station (LABINS;DOQQ; State Plane East; Casselberry; jpeg 2004). Shovel tests are not to scale.
