Table 1
Contamination Risk Potential Sites
CENTRAL FLORIDA COMMUTER RAIL PROJECT
Proposed Fort Florida Road, Longwood, Altamonte Springs, Maitland Stations
FDOT Financial Project No. 412994-2-22-01

Subject: Longwood Station Level I Contamination Screening Evaluation Report
Addendum 2

Central Florida Commuter Rail Transit Project

Subject: Maitland Station Level I Contamination Screening Evaluation Report
Addendum 1
Central Florida Commuter Rail Transit Project
Volusia, Seminole, Orange and Osceola Counties, Florida
GEC Project No. 2135E2

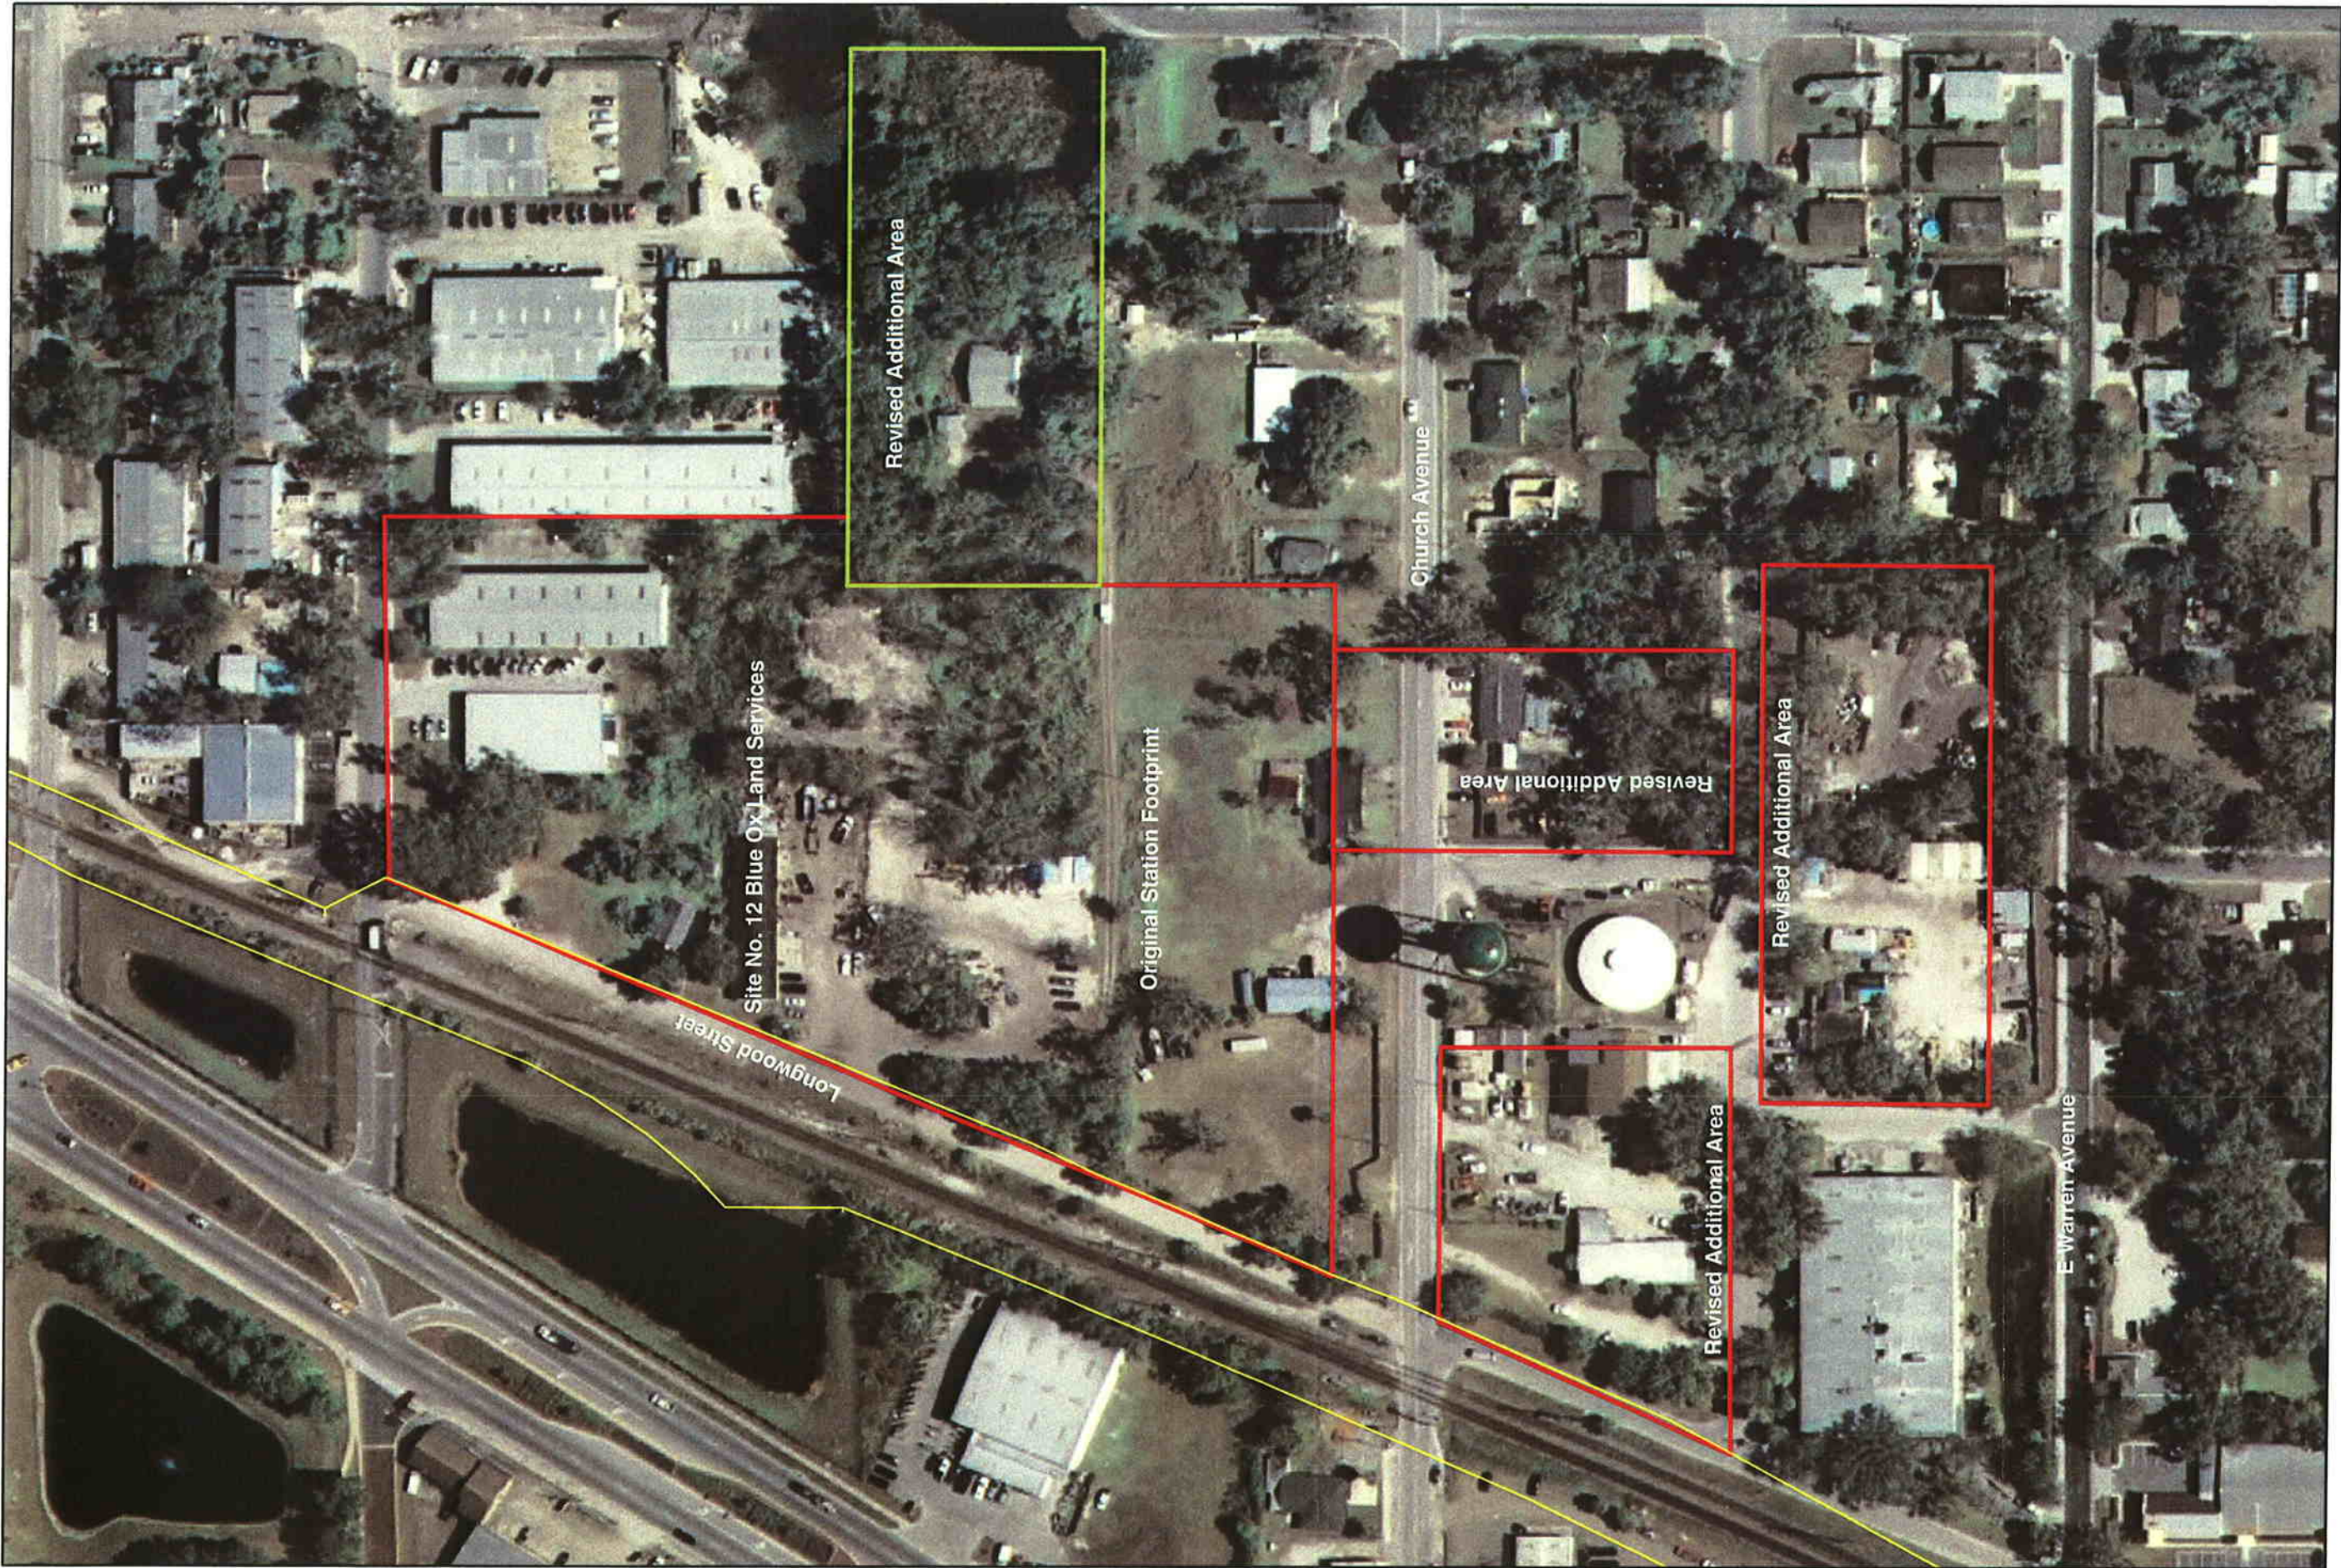
REVISED LONGWOOD STATION LAYOUT

The newly added section of the Longwood Station is located east of the original Longwood Station footprint. This area consists of four parcels of land. These parcels include Parcel ID No. 31-20-30-5AU-0000-4520 owned by William E Adams, Parcel ID No. 31-20-30-5AU-0000-4500 owned by Ralph Lembrich, Parcel ID No. 31-20-30-5AU-0000-4420 owned by the State of Florida, and Parcel ID No. 31-20-30-5AU-0000-4510 owned by the State of Florida as stated on the Seminole County Property Appraiser's website. The Adams and Lembrich properties are residential, while the State of Florida land is undeveloped and covered with dense vegetation. Please see **Figure 1** for the updated Longwood Station layout.

- Approximate station footprint
(Level I and Level II Assessment
previously performed)
- Approximate station footprint
(Not previously investigated)
- CSX right-of-way

As part of the contamination screening activities conducted for the parcel depicted on **Figure 1**, GEC performed a site reconnaissance and historical aerial photograph review. An updated database search was not performed. The following sections summarize the activities and results conducted for this CSER Addendum. The Contamination Risk Potential Ratings (CRPRs) provided herein are consistent with the definitions included in Chapter 22 of the FDOT Project Development and Environment (PD&E) Manual.

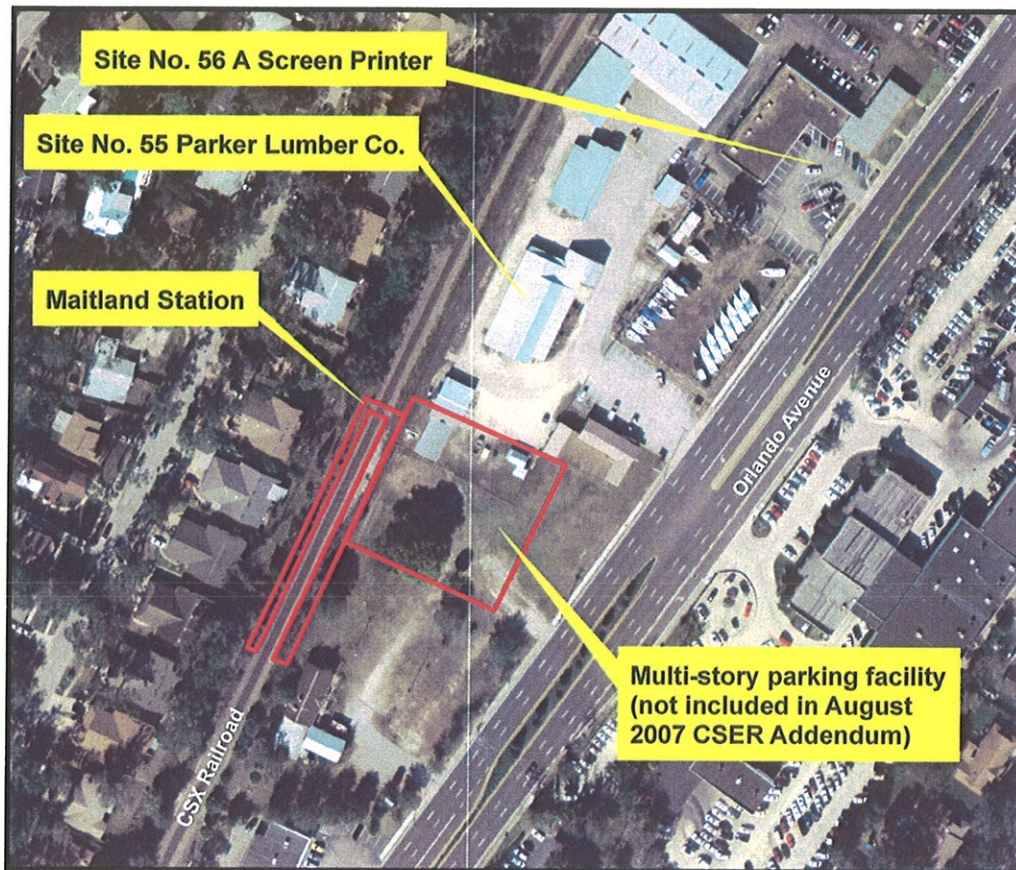
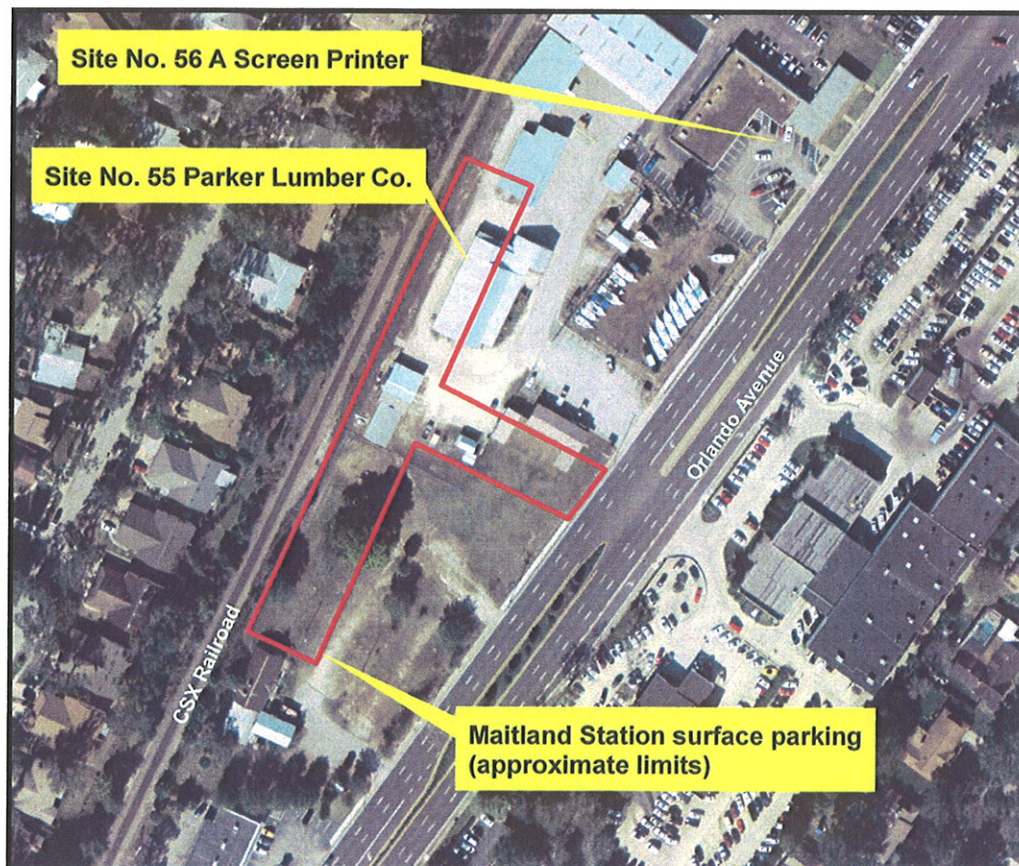
FIGURE 2

This CSER Addendum 1 is being conducted to address the new parking facility proposed for the Maitland Station, which includes a paved parking lot replacement of the multi-story parking garage. **Figure 1** shows the Maitland Station location along the CFCRT project route. **Figure 2** presents the previous and current layouts. Layout No. 2 on **Figure 2** depicts the Maitland Station layout that is the subject of this investigation.

The parking facility for the Maitland Station is located adjacent to the CSX Railroad tracks, southwest of the intersection of Maitland Boulevard and Orlando Avenue (US Highway 17-92) in Section 25, Township 21 South, and Range 29 East and Section 30, Township 21 South, and Range 30 East. This parking area currently consists of undeveloped land and a portion of the Parker Lumber Company. The station also has frontage to Orlando Avenue, as shown on **Figure 2**.

It should be noted that the current parking limits (Layout No. 2 on **Figure 2**) intersect a significant portion of Parker Lumber Company. The limits of the previously planned multi-story parking garage, which was included in the August, 2007 CSER Addendum, did not encompass a significant portion of the Parker Lumber facility.

Layout No. 1, August 2007

Layout No. 2, December 2007

As part of the contamination screening activities conducted for the parking facility depicted as Layout No. 2 on **Figure 2**, GEC performed a site reconnaissance, historical aerial photograph review, and review of previous documents completed for the CFCRT Project. An updated database search was not performed. The following sections summarize the activities and results conducted for this CSER Addendum. The Contamination Risk Potential Ratings (CRPRs) provided herein are consistent with the definitions included in Chapter 22 of the FDOT Project Development and Environment (PD&E) Manual.

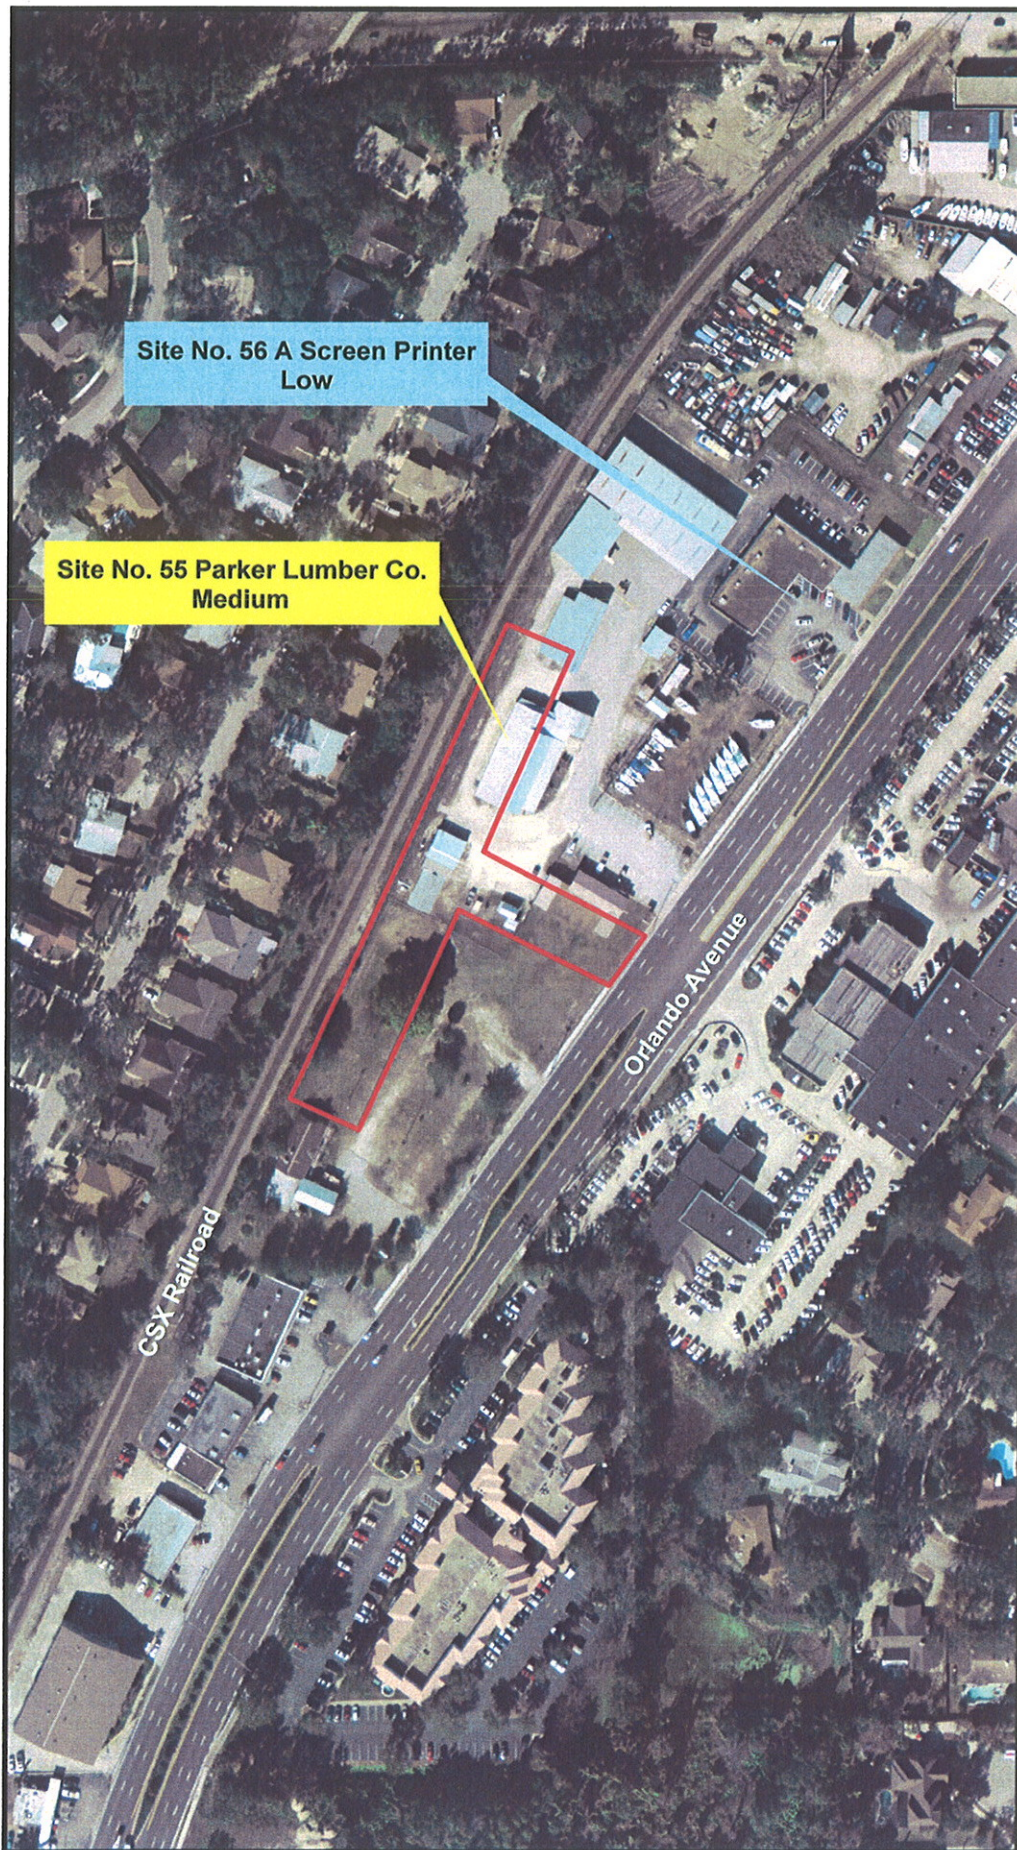
FIGURE 3

The following sites were identified as contamination risk potential sites as a result of this Level I CSER Addendum and are shown on **Figure 3**.

Site No. 55 - Parker Lumber Company, Inc., 851 N. Orlando Avenue. Parker Lumber Company, Inc. is located on the northern portion of the proposed Maitland Station. During GEC's site reconnaissance, this facility appeared well maintained and there were no obvious signs of impacts to soil in the area of the proposed Maitland Station. According to the FSTC Report, which was obtained in October 2006, one 500-gallon underground unleaded gasoline tank was removed on April 30, 1990. According to the FDEP, a Tank Closure Report was not required at that time. Additionally, a total of two tanks were listed as in service (one 270-gallon petroleum additive aboveground tank and one 55-gallon lube oil above ground tank). According to the interview with Larry Parker, there are no petroleum tanks at the Parker Lumber Company facility. This was confirmed during GEC's site reconnaissance, conducted on December 6, 2007. Based on a file review conducted at Orange County Environmental Protection Division, no violations were reported to regulatory agencies at the time of our CSER.

Although not required in 1990, a Tank Closure Report would be required by current regulations. This facility was assigned a CRPR of No in the August 2007 Addendum because it was outside the proposed station footprint, and construction of the parking facility was not to be considered as previously stated. However, the current station layout is comprised of a significant portion of the Parker Lumber Company facility including areas where facility operations have historically occurred. As such, this facility has been re-assigned a CRPR of **Medium**.

Site No. 56 - A Screen Printer, 915 N. Orlando Avenue. This facility is located adjacent to the northeast of the proposed Maitland Station. In previous reports, this facility was identified in the FSTC Report to be Executive Top Quality Cleaner, listed as a FINDS and RCRA site. Based on GEC's site reconnaissance and interviews conducted during this Addendum, this facility is currently operating as a screen printing business and is not listed as a hazardous waste generator in the public record. As previously stated, Larry Parker of Parker Lumber has stated that this facility has never been operated as Executive Dry Cleaner. No violations or discharges were found in the public record. Therefore, this facility was assigned a CRPR of **Low**.

Approximate Maitland
surface parking
lot footprint

Parker Lumber Company, Inc. (Medium). Based on the proposed project design changes to the parking facility, GEC recommends conducting soil and groundwater

investigations on the portion of the Parker Lumber Company that will be utilized for the Maitland Station. The investigations would be conducted to evaluate potential liability associated with right-of-way acquisition and construction of the re-configured parking facility.

A Screen Printer (Low). GEC does not recommend further testing at this facility.
